Elements: Damage Report

Gray Sky Damage Assessment

289/291 Tropical Shore Way
Fort Myers Beach FL 33931
United States

Thu, 1 June 2023

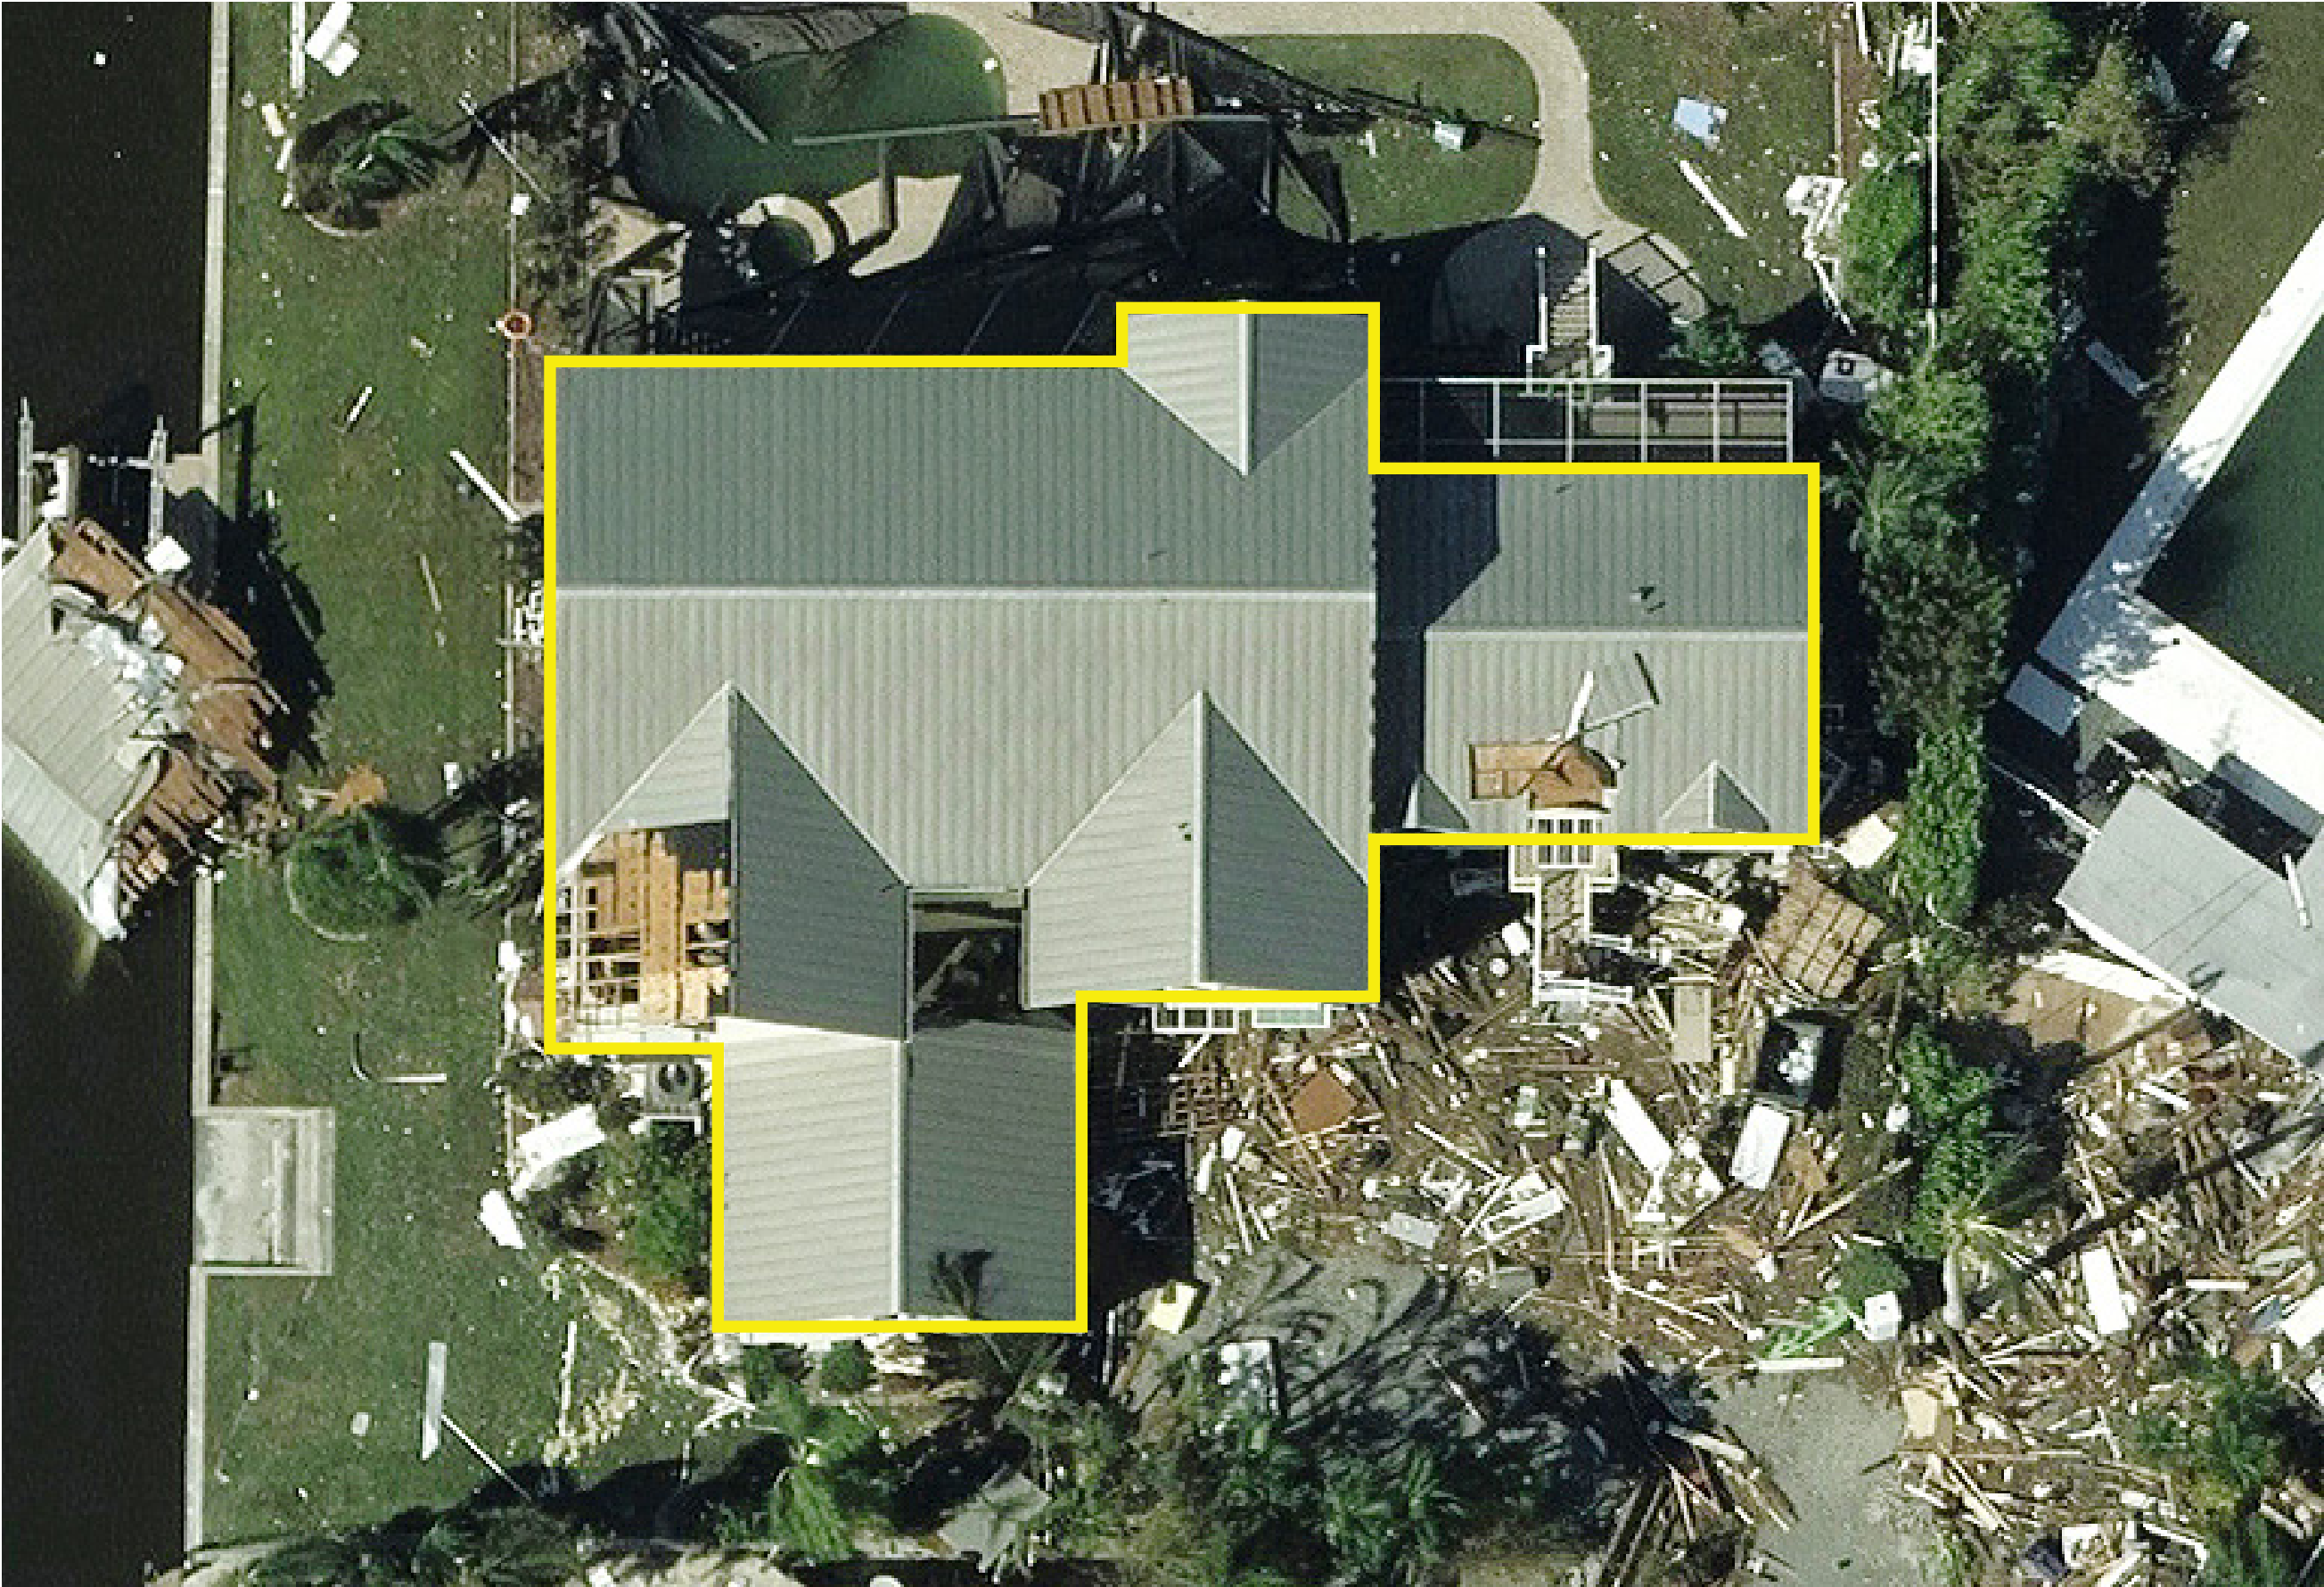
Damage Report: Primary Building Assessment + Footprint

Attribute	Value
Catastrophe score	50/100
Approx. FEMA score	FEMA 3 / Moderate
Roof structure damage	1.4%
Missing material	0.2%
Tarp covering roof	0%
Roof debris	0%
Roof discoloration	0.07%

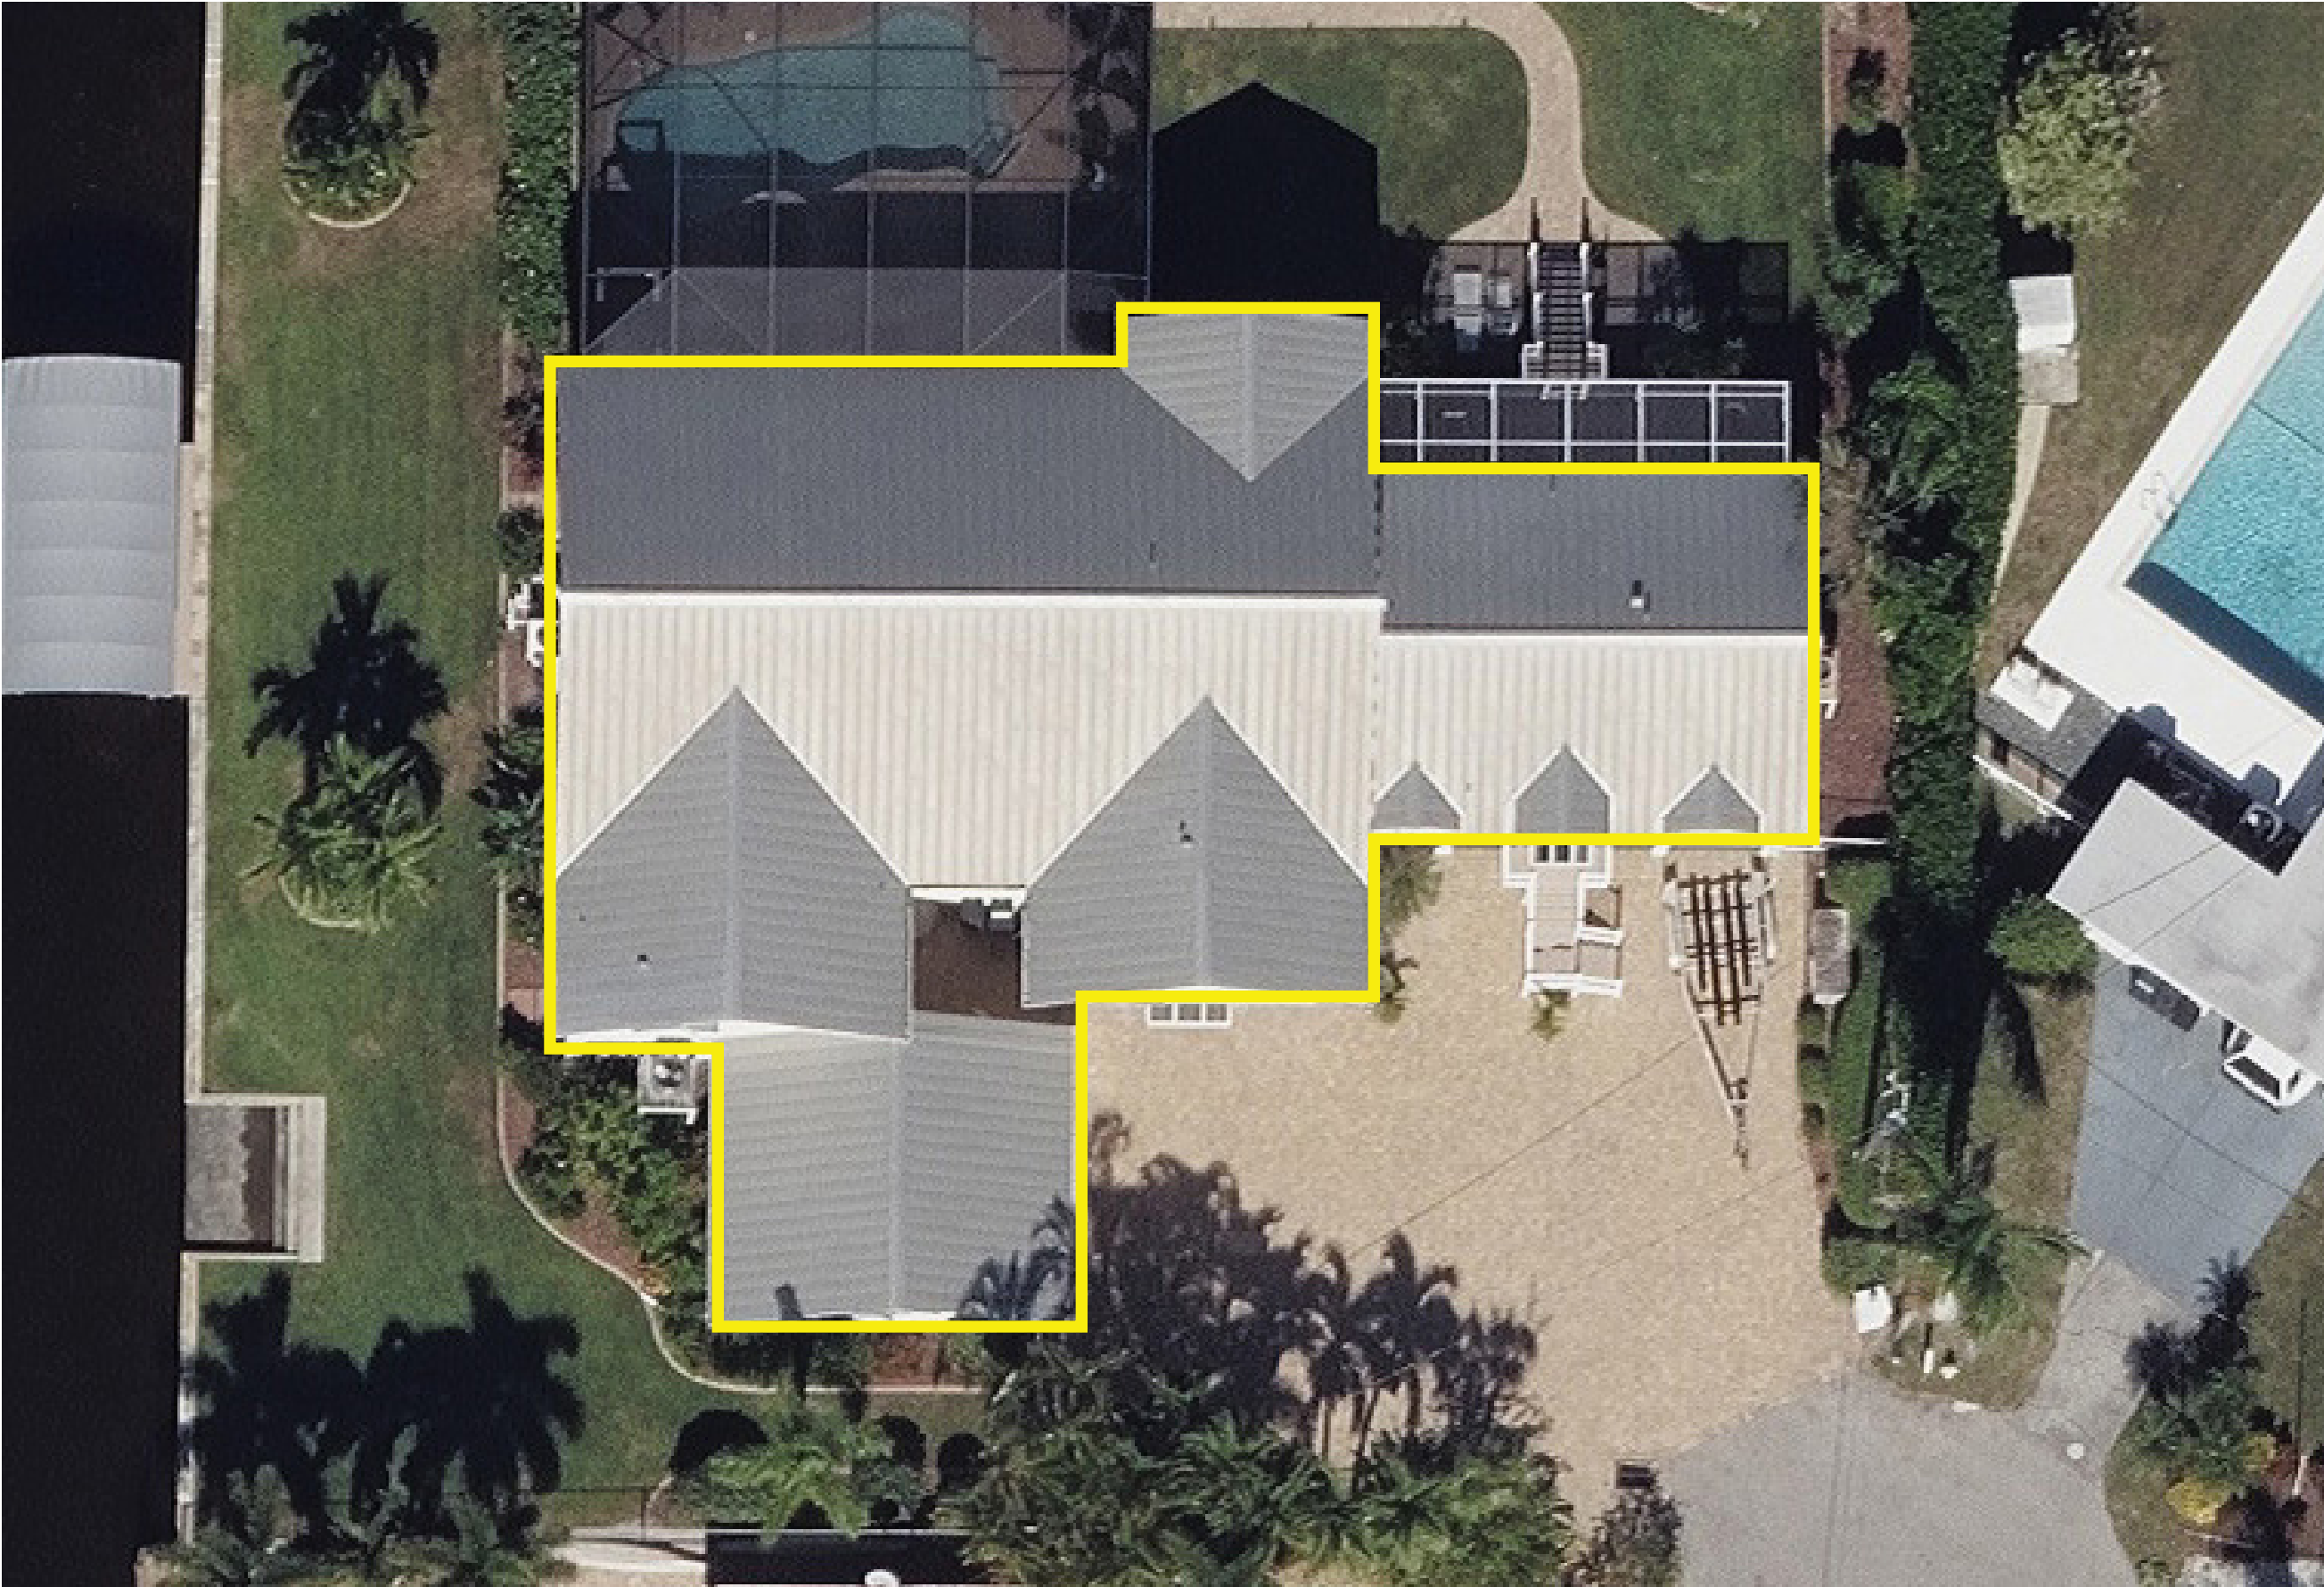
Pre-Damage Report: Primary Building Attributes + Footprint

Attribute	Value	Confidence
Ground elevation	0.98 ft	
Footprint area	5590.77 ft ²	
Roof material	metal	100%
Missing roof material	0%	N/A
Roof condition	5/5	
Roof discoloration	0%	N/A
Roof tarp	0%	N/A
Roof shape	gable	99%
Roof solar	No	N/A
Roof centroid	26.453549 -81.942335	
Tree cover over roof	0%

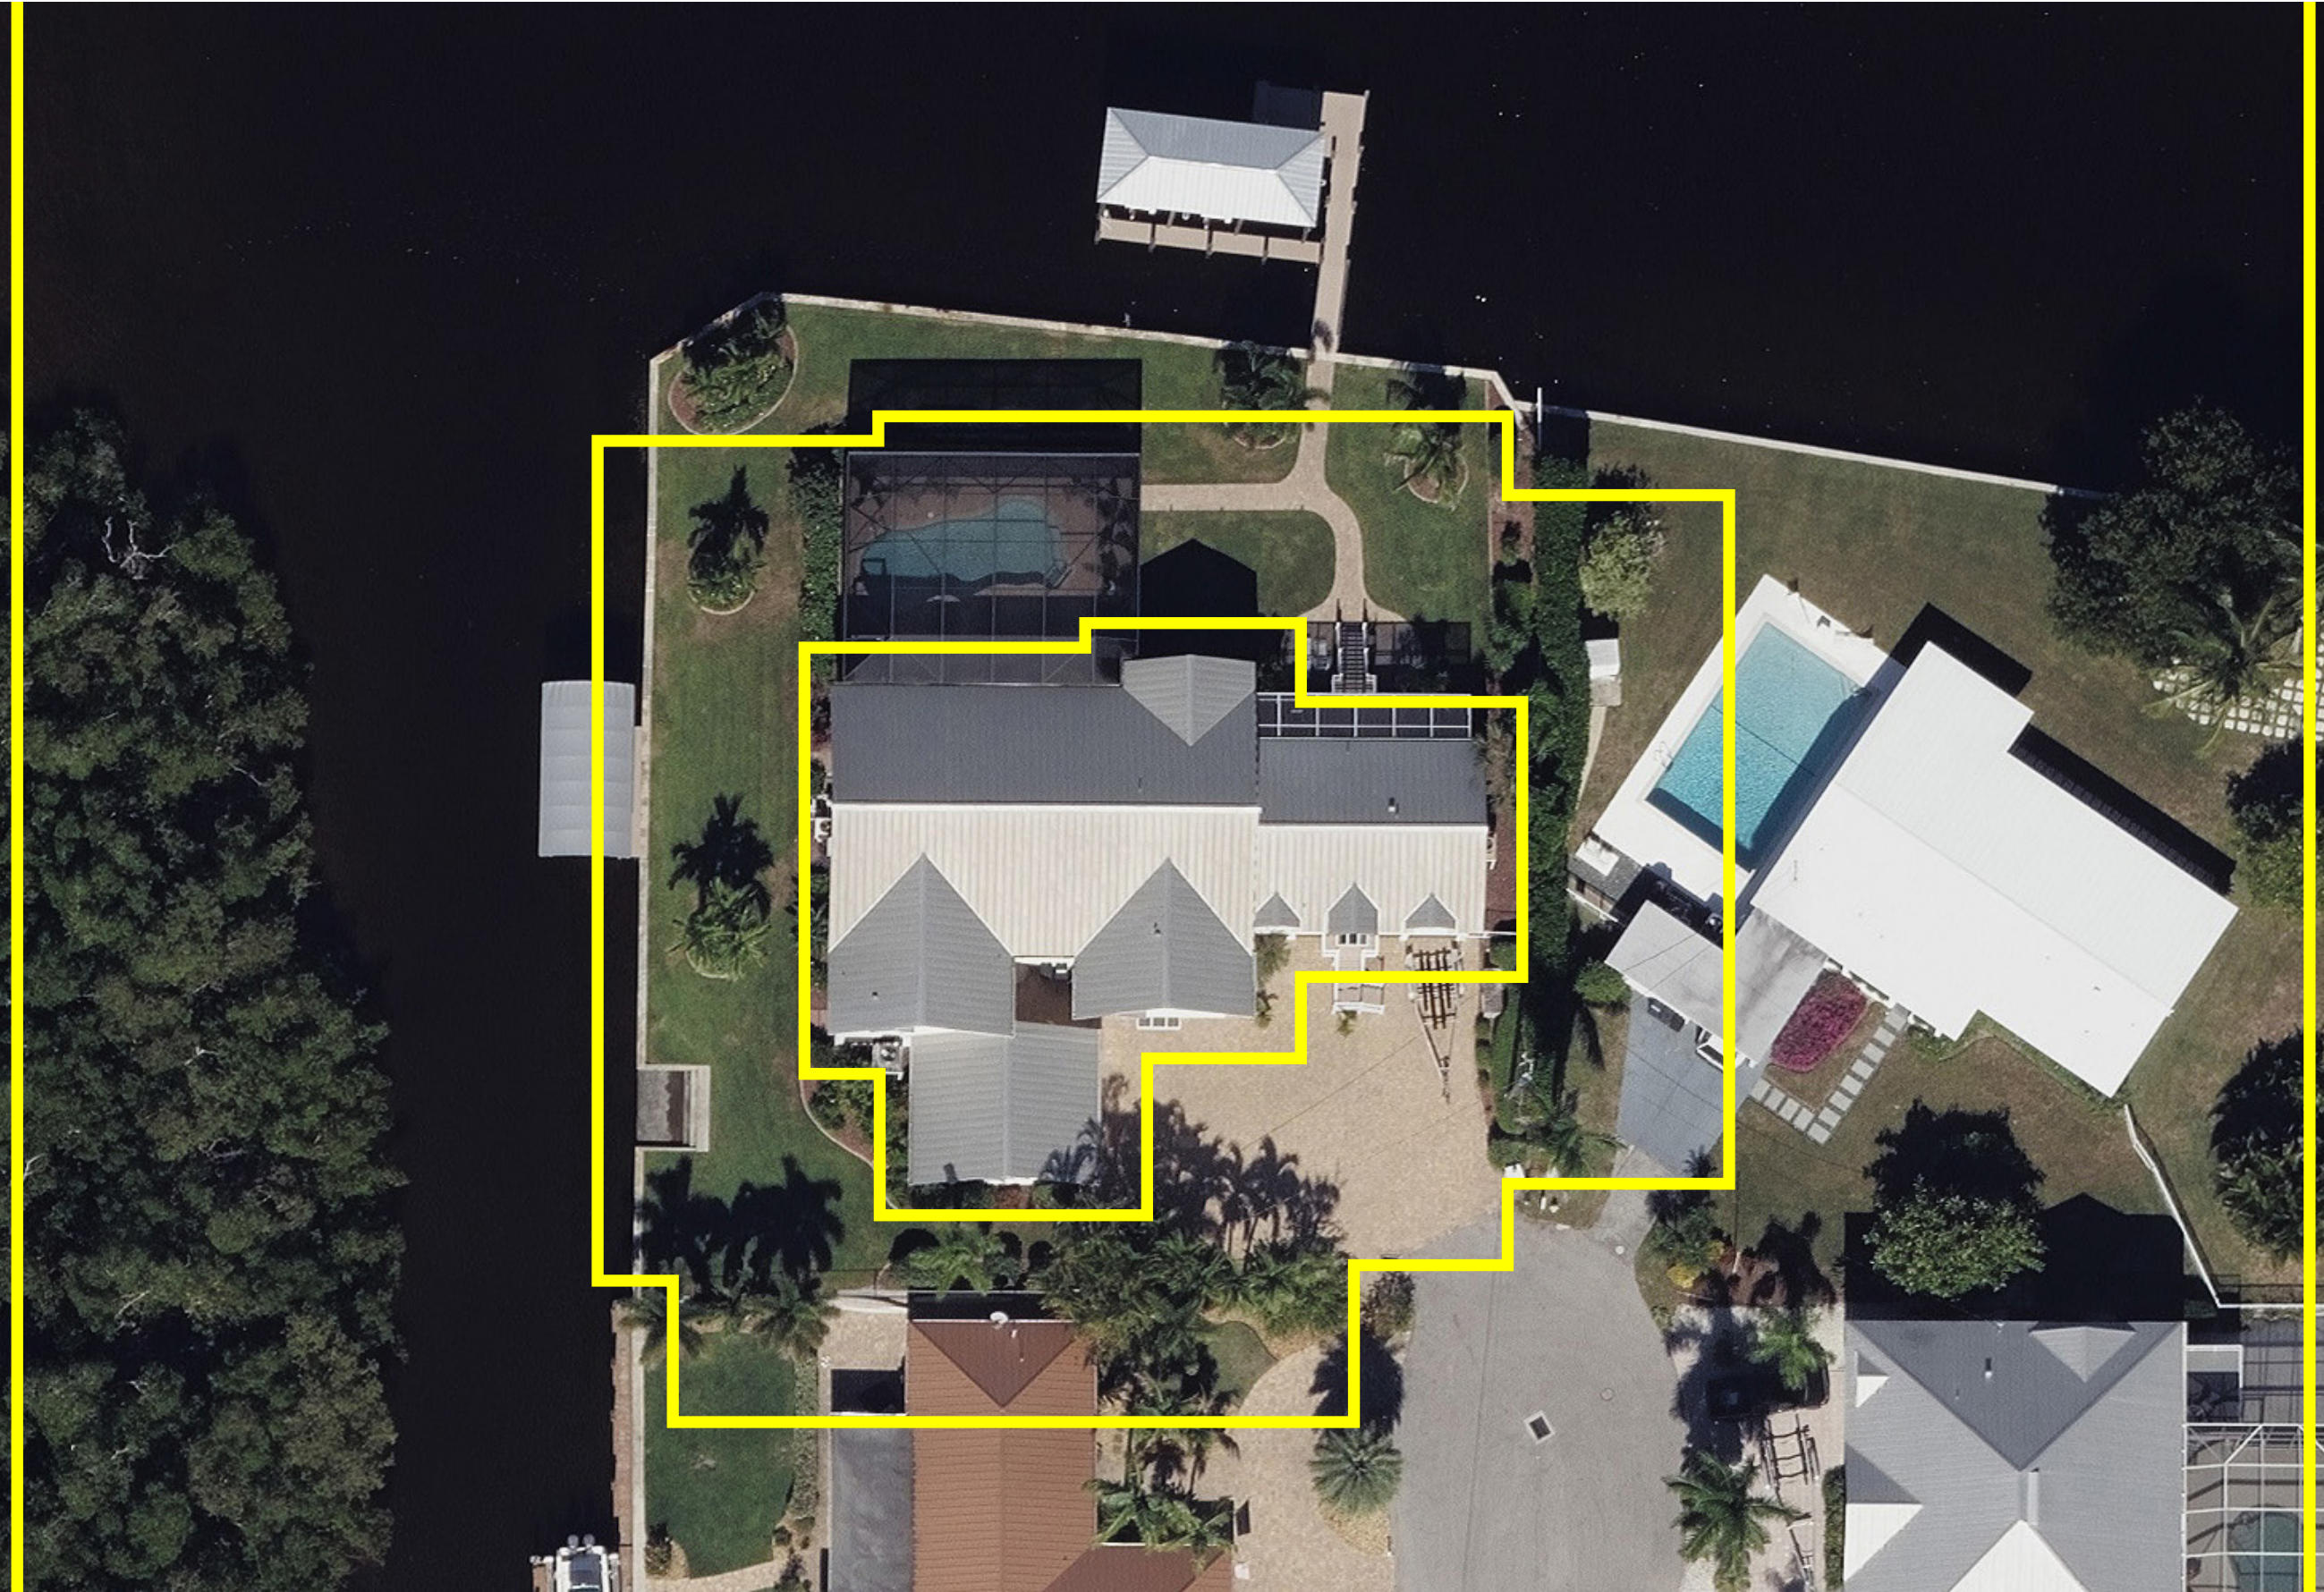
Pre-Damage Report: Defensible Space

Defensible Space	Value
DSB 5 ft	N/A
DSB 30 ft	2%
DSB 100 ft	11%
DSB 200 ft	N/A
DST 5 ft	N/A
DST 30 ft	12%
DST 100 ft	12%
DST 200 ft	N/A
