# Elements: Damage Report

Gray Sky Damage Assessment

725 Lydia Court  
Harvey LA 70058  
United States

D89122101VE

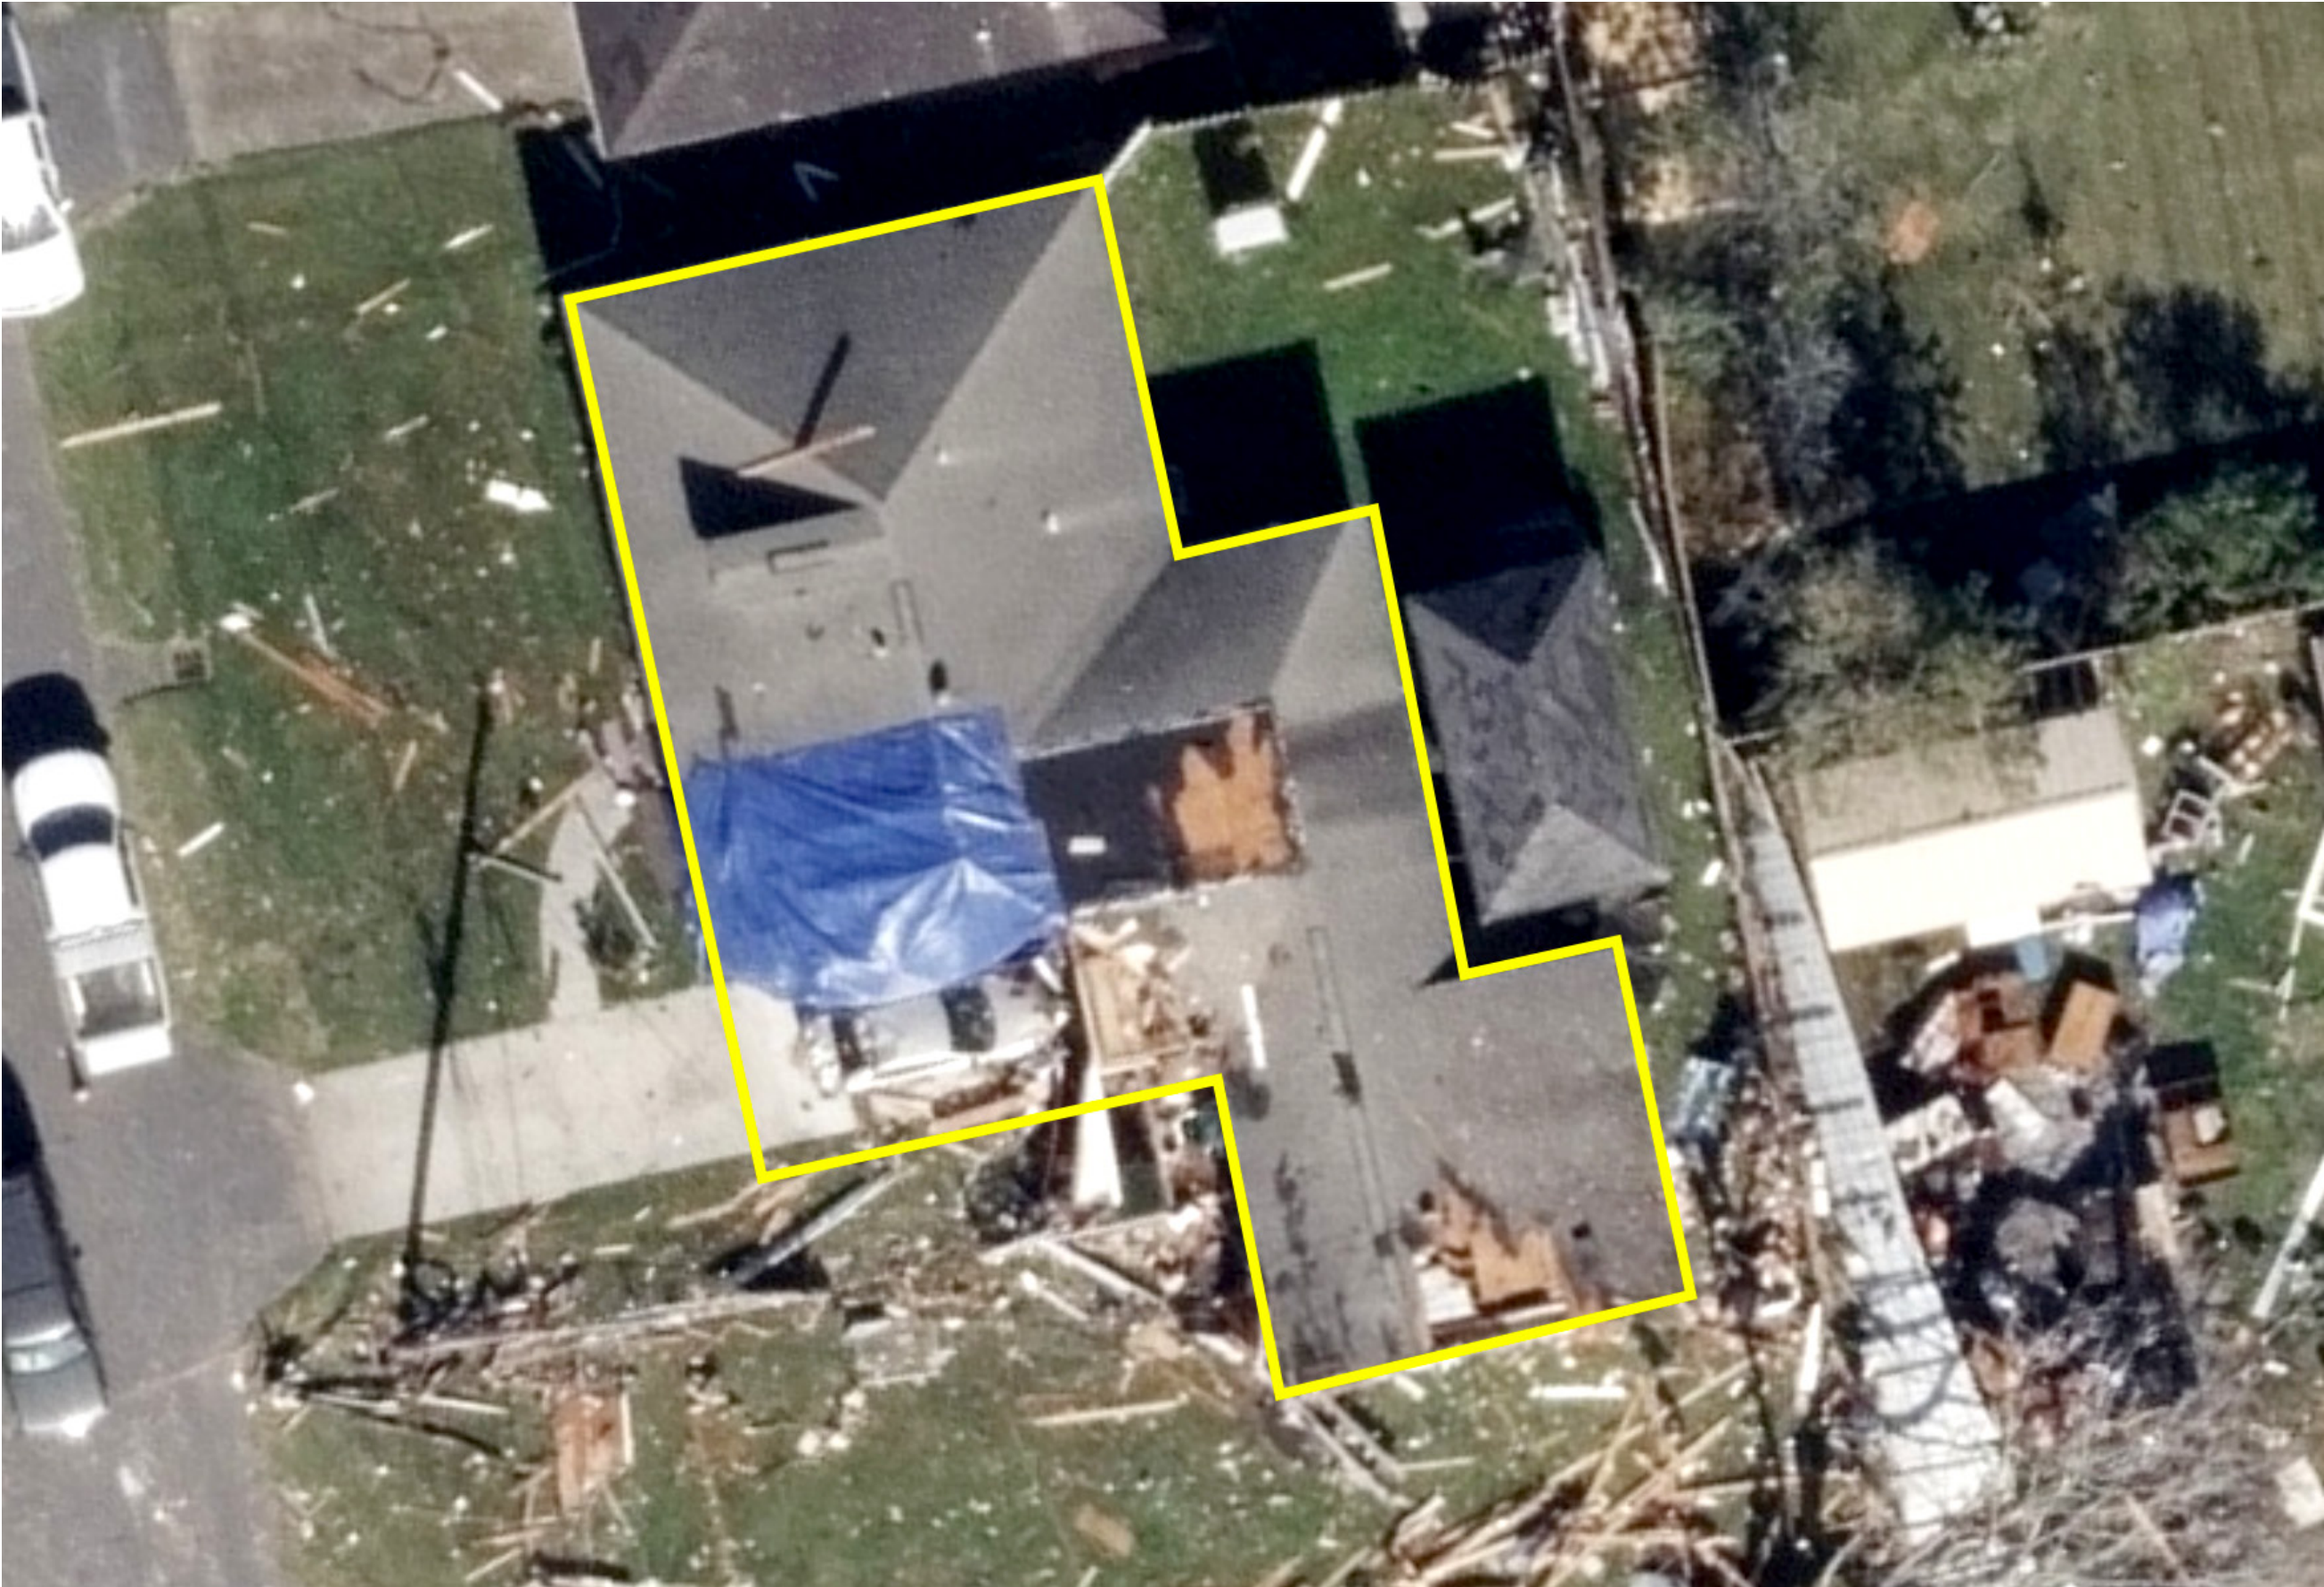
# Damage Report: Primary Building Assessment + Footprint

Analysis based on 15 December 2022 imagery

Attribute	Value
Catastrophe score	64/100
Approx. FEMA score	FEMA 4 / Major
Roof structure damage	5.32%
Missing material	10.56%
Tarp covering roof	12.89%
Roof debris	0%
Roof discoloration	27.9%

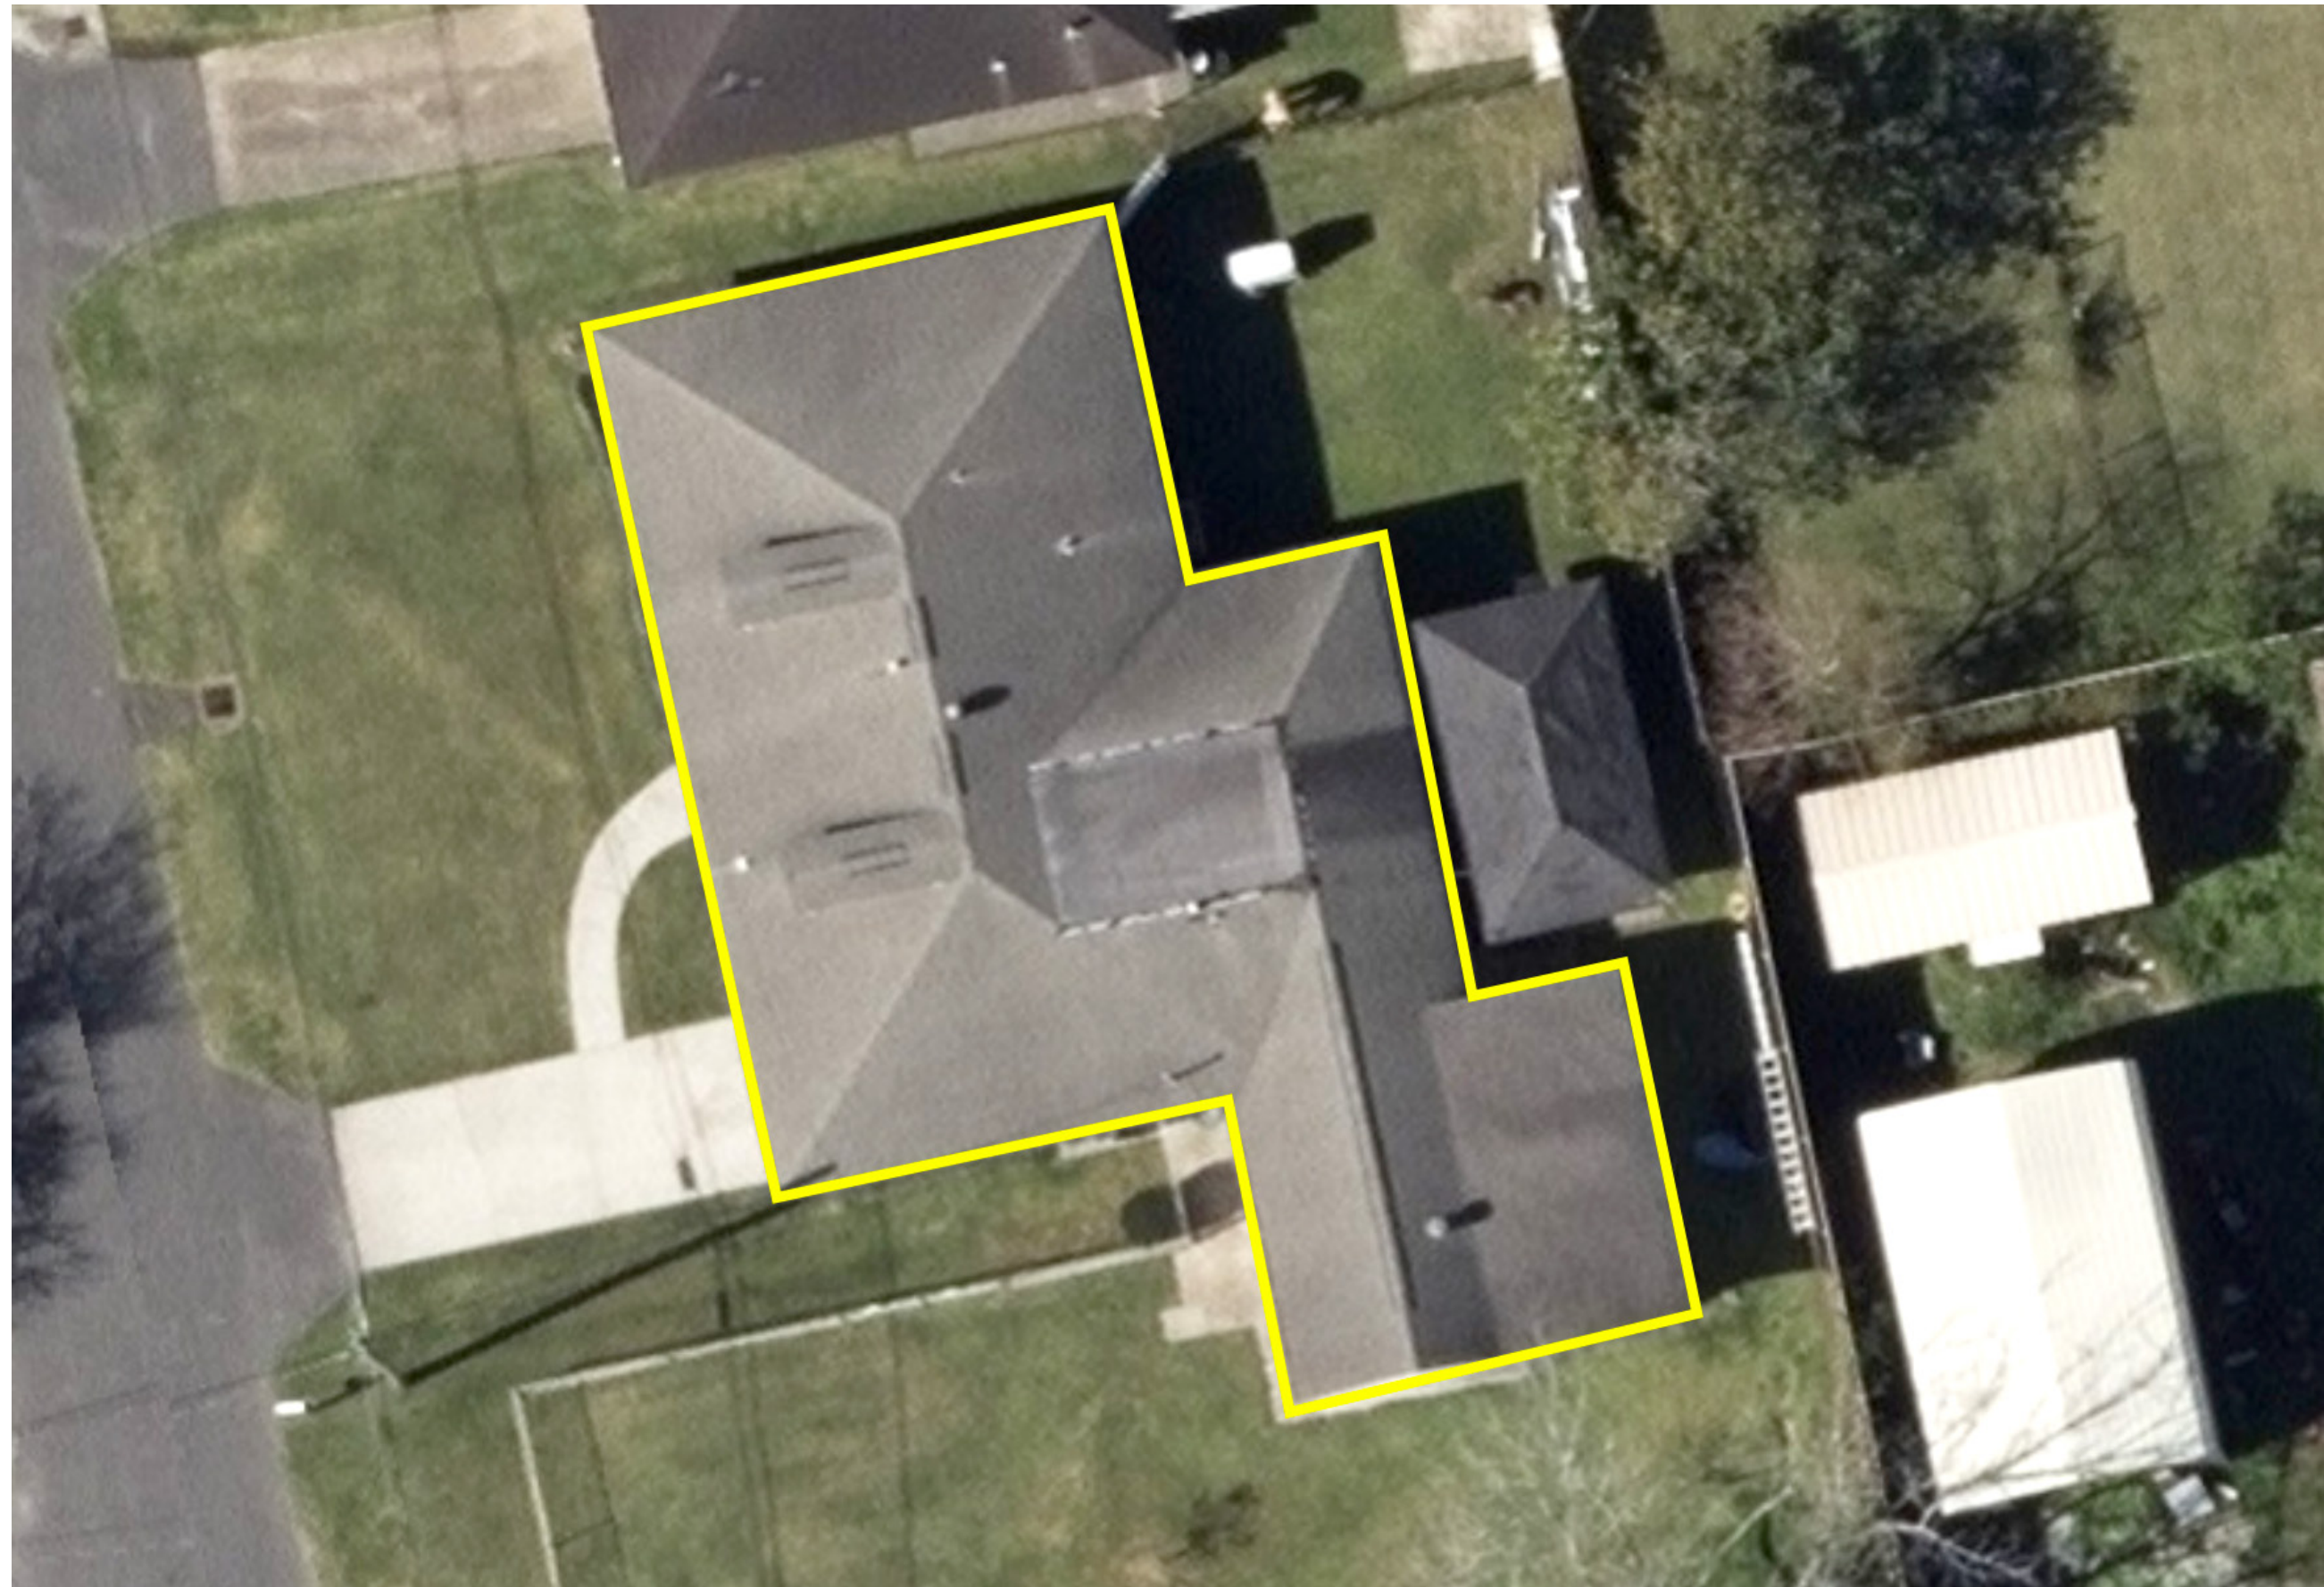
# Pre-Damage Report: Primary Building Attributes + Footprint

Analysis based on 23 March 2022 imagery

Attribute	Value	Confidence
Ground elevation	2.99 ft	
Footprint area	3080.09 ft <sup>2</sup>	
Roof material	shingle	100%
Missing roof material	0%	N/A
Roof condition	3/5	
Roof discoloration	0%	N/A
Roof tarp	0%	N/A
Roof shape	hip	97%
Roof solar	No	N/A
Roof centroid	29.899211 -90.089779	
Tree cover over roof	0%

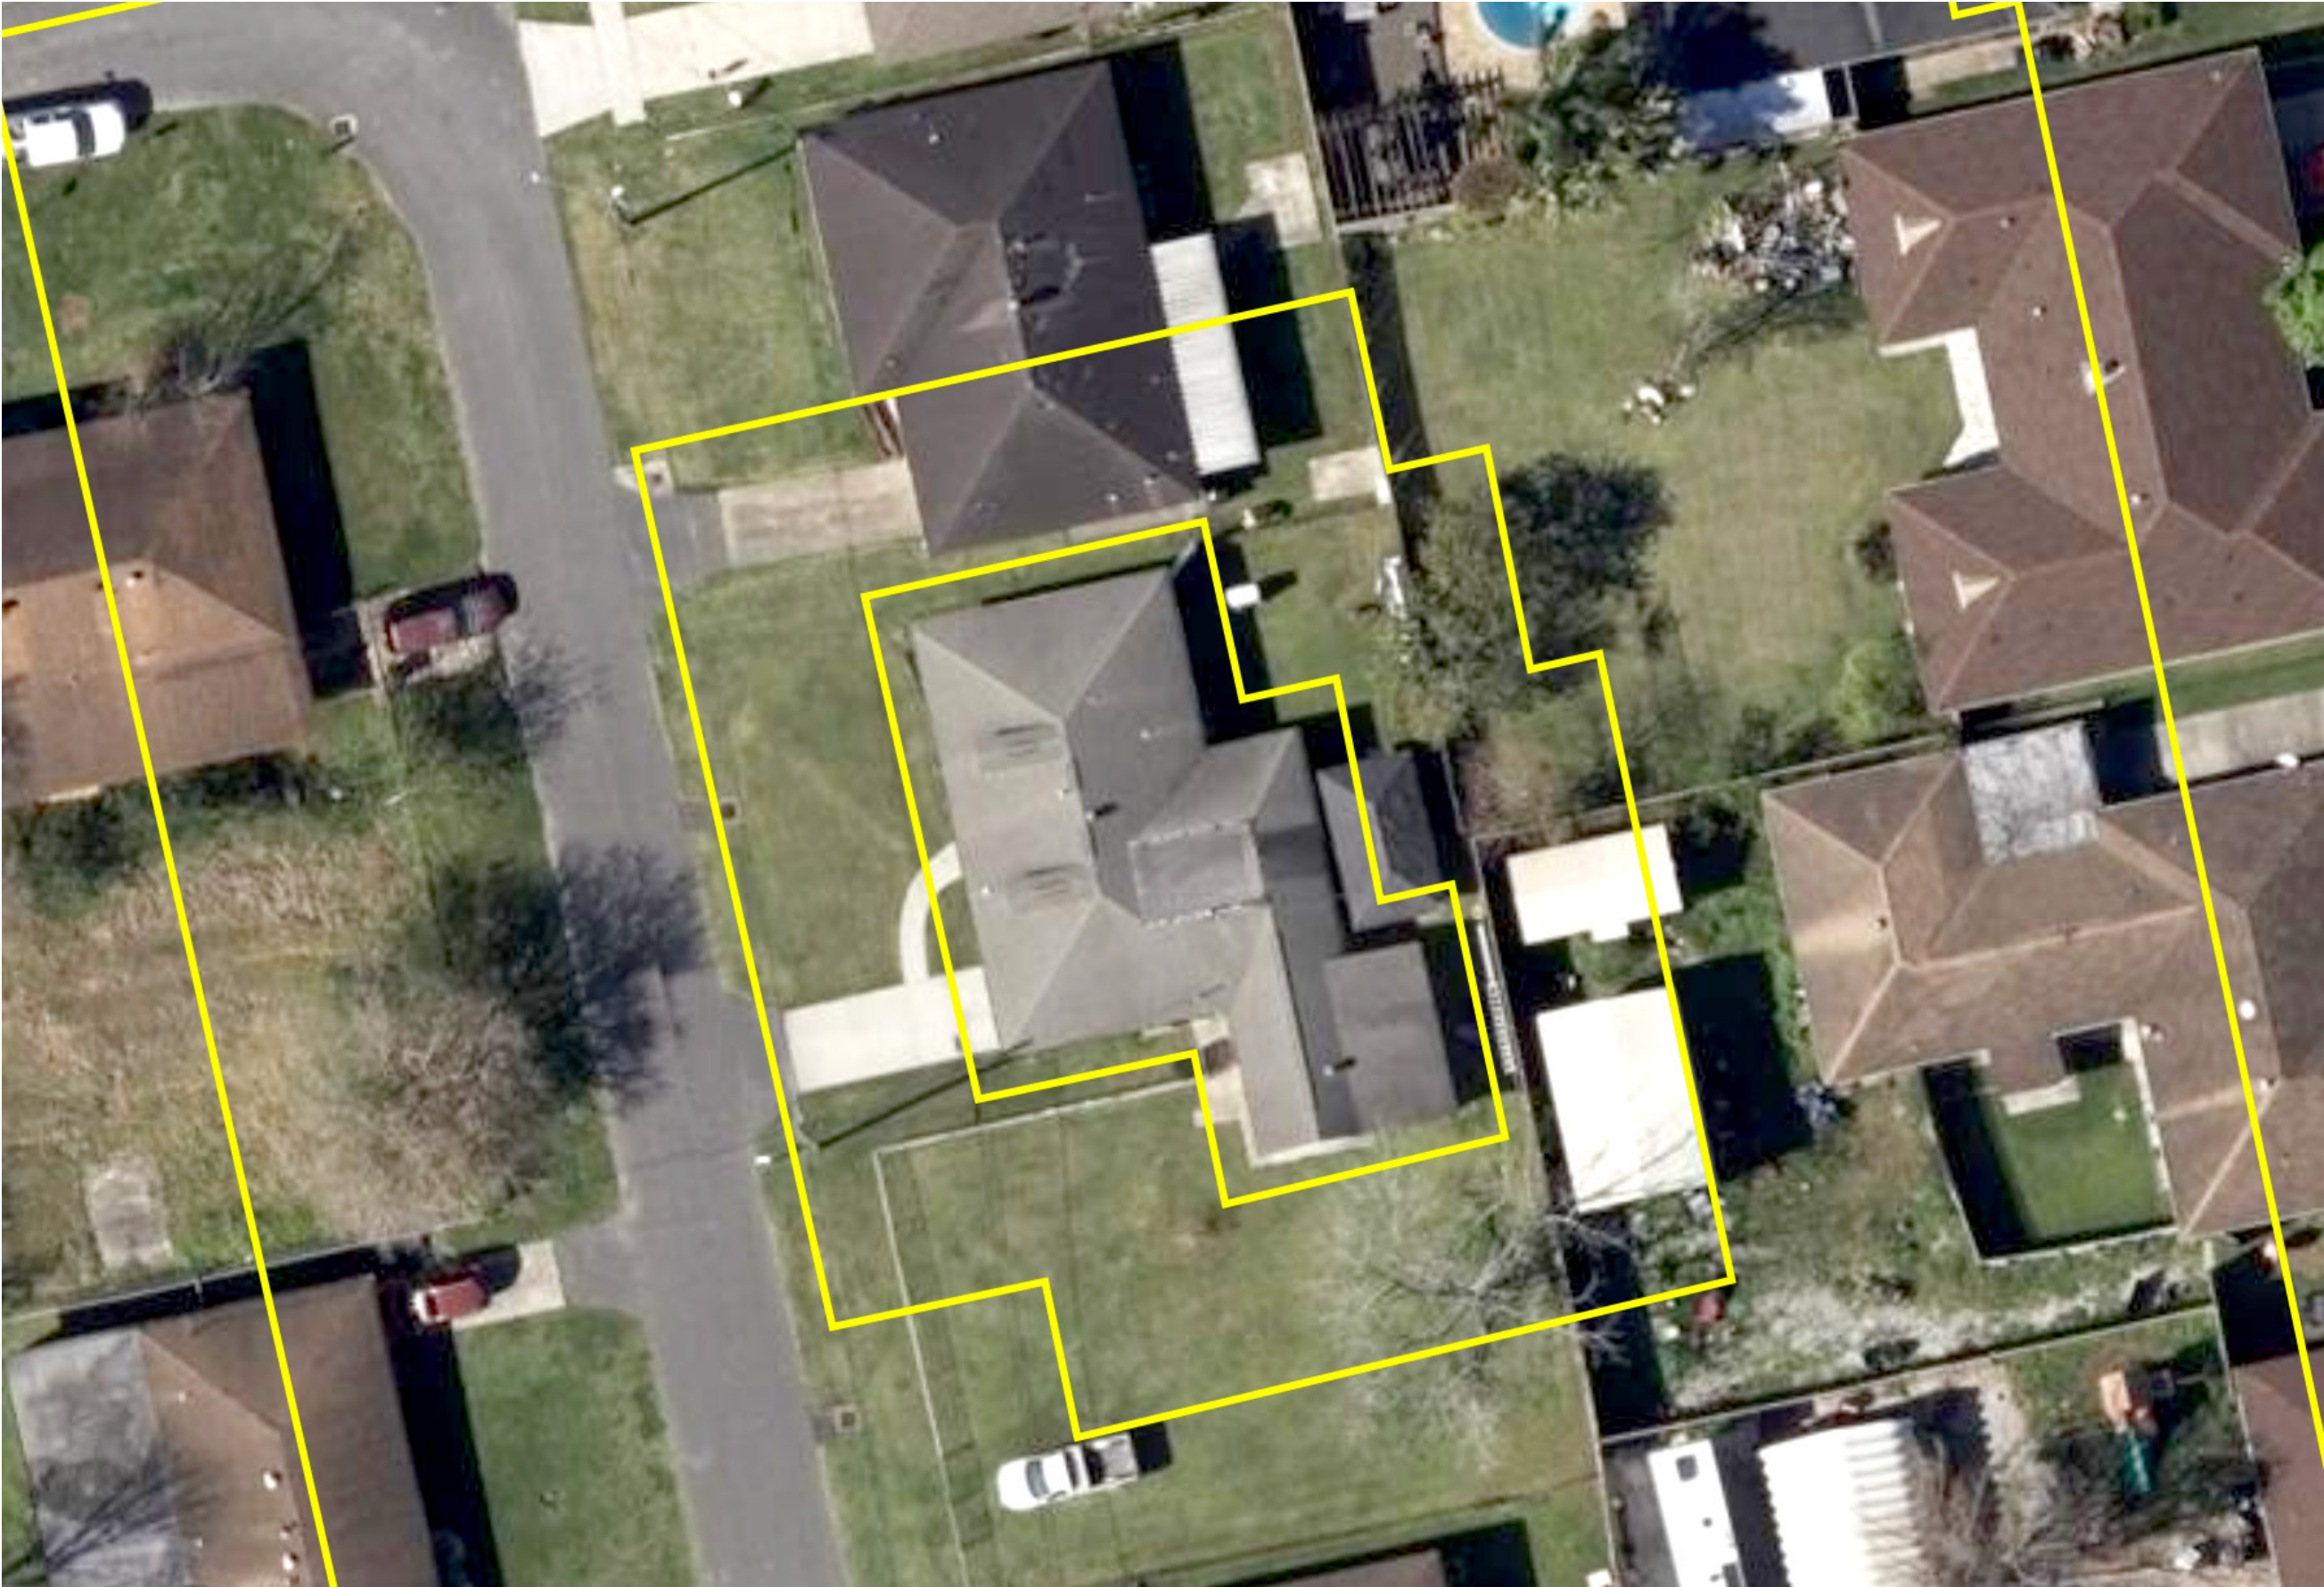
# Pre-Damage Report: Defensible Space

Analysis based on 23 March 2022 imagery

Defensible Space	Value
DSB 5 ft	N/A
DSB 30 ft	17%
DSB 100 ft	23%
DSB 200 ft	N/A
DST 5 ft	N/A
DST 30 ft	13%
DST 100 ft	10%
DST 200 ft	N/A
