Elements: Damage Report

Gray Sky Damage Assessment

2408 Hatcher Mountain Road
Pigeon Forge TN 37862
United States

D62293491VE

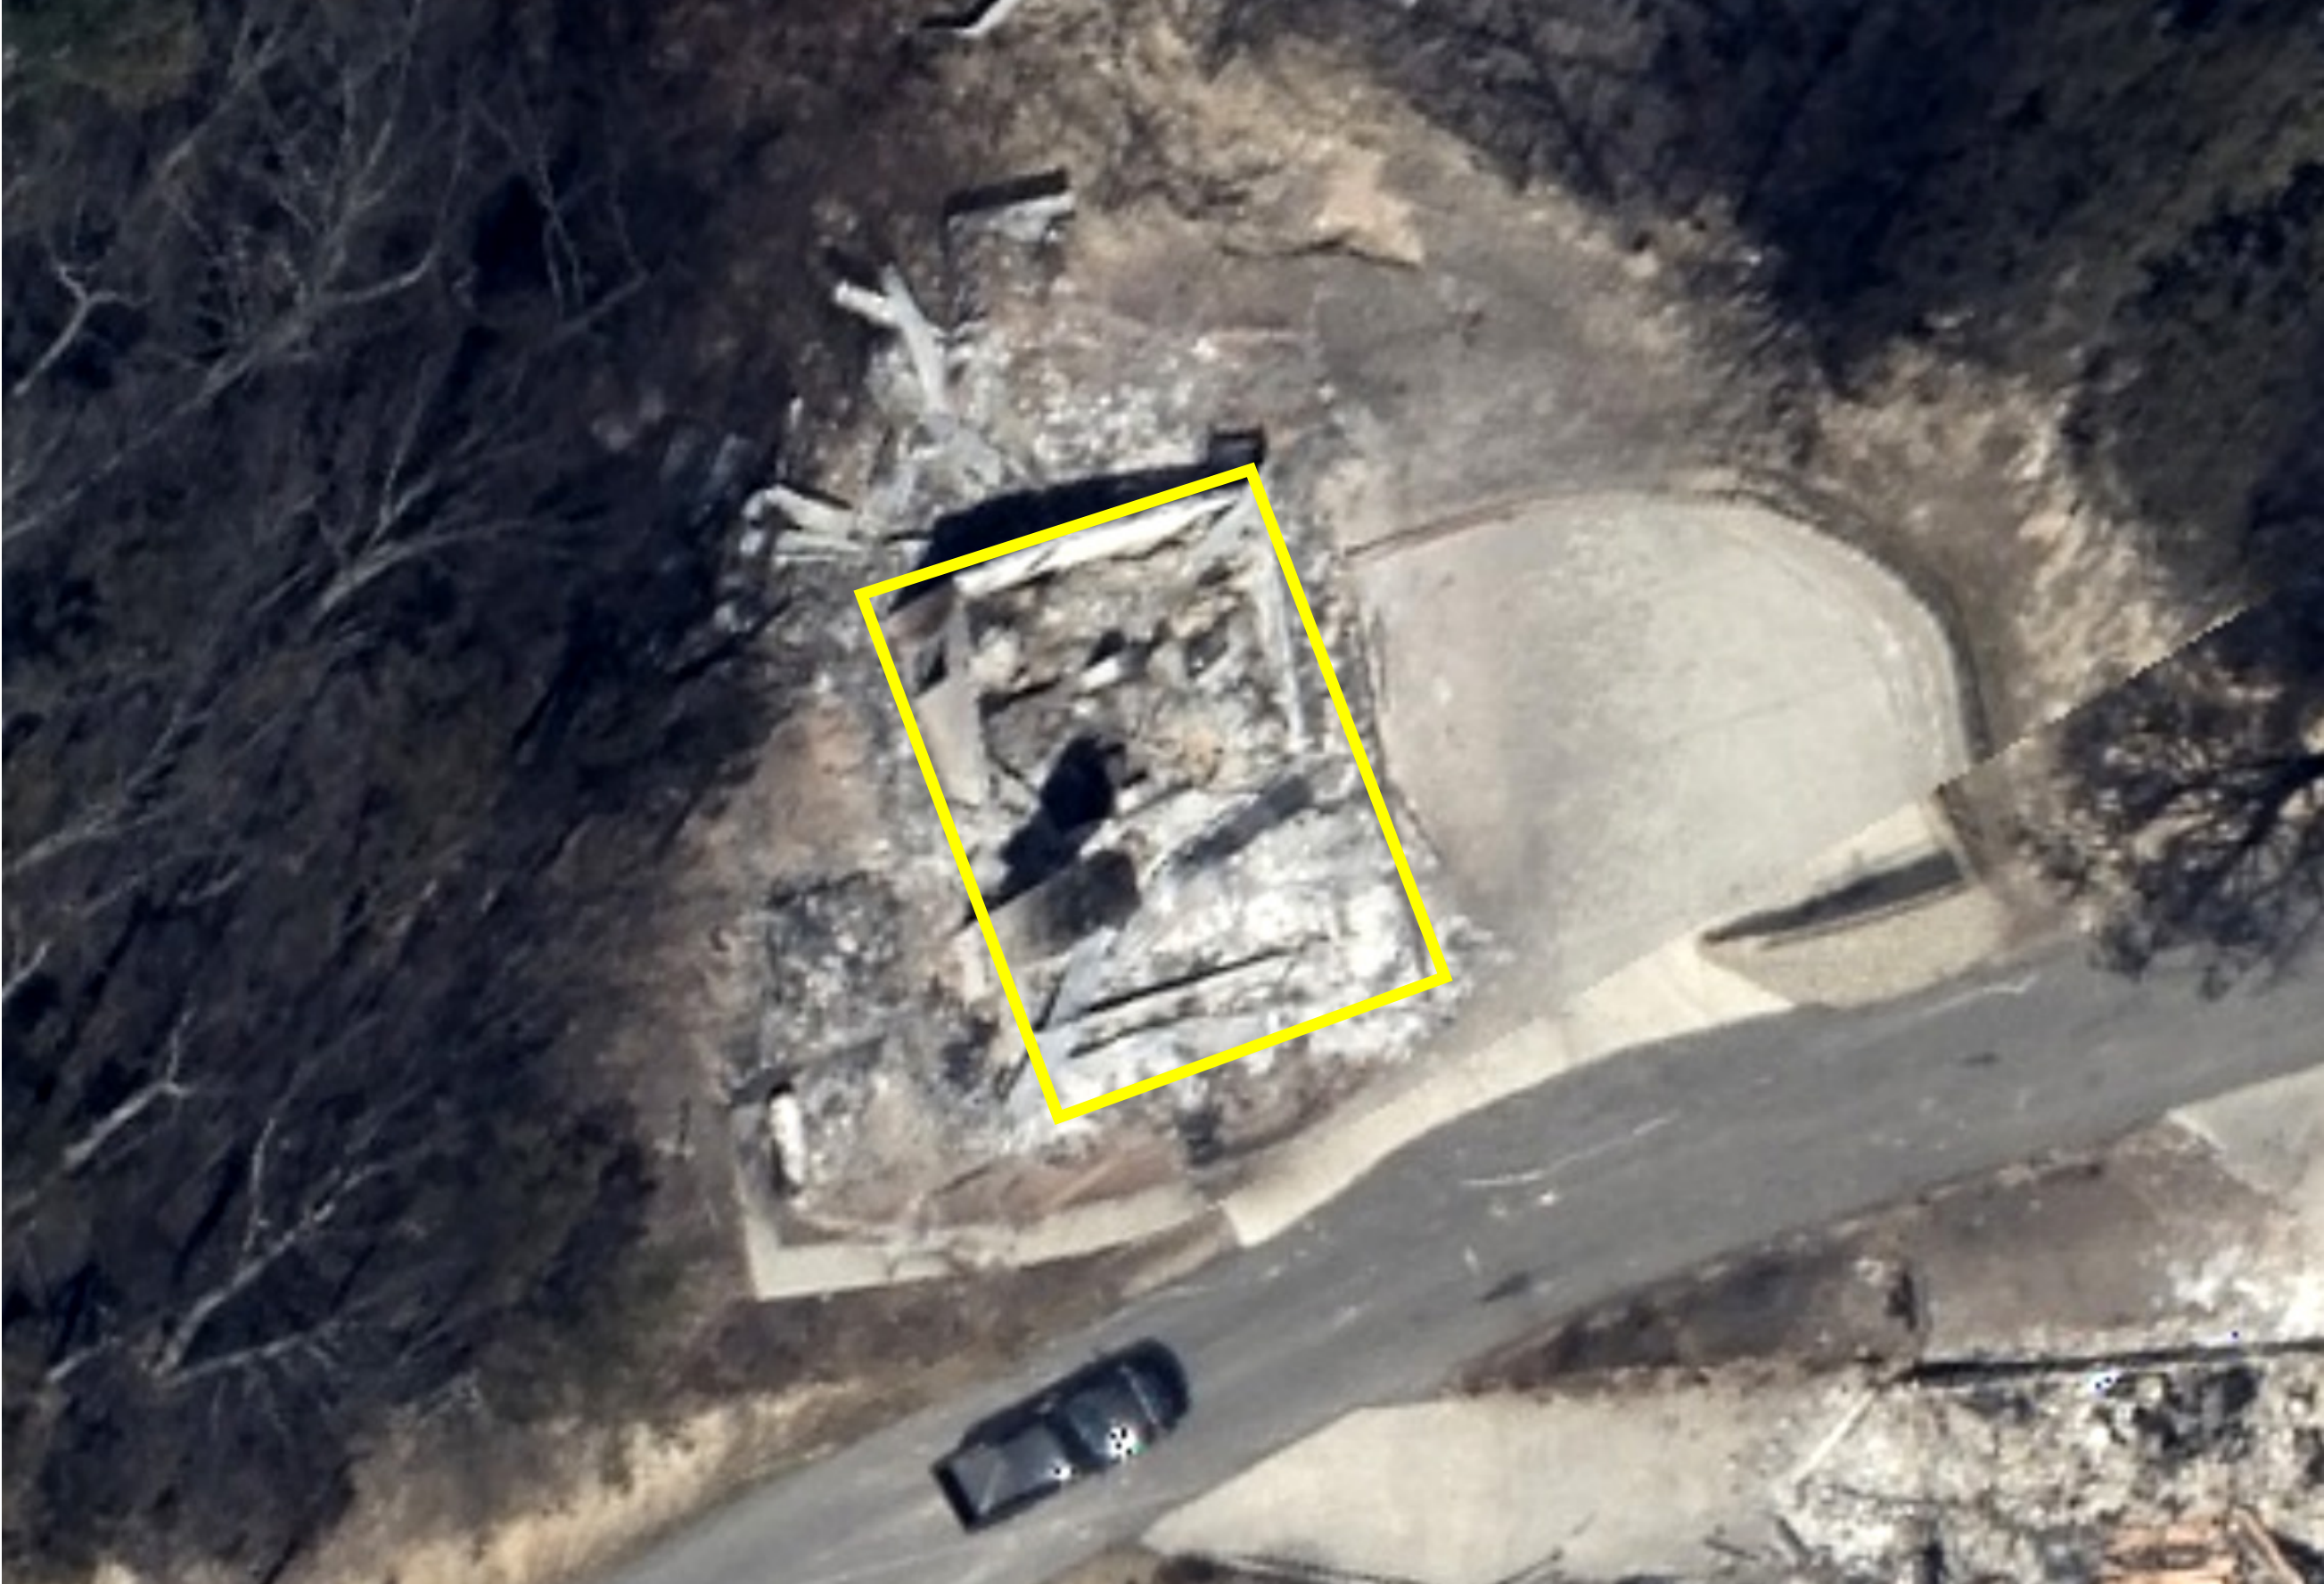
Damage Report: Primary Building Assessment + Footprint

Analysis based on 04 April 2022 imagery

Attribute	Value
Catastrophe score	100/100
Approx. FEMA score	FEMA 6 / Destroyed
Roof structure damage	0%
Missing material	0%
Tarp covering roof	0%
Roof debris	0%
Roof discoloration	0%

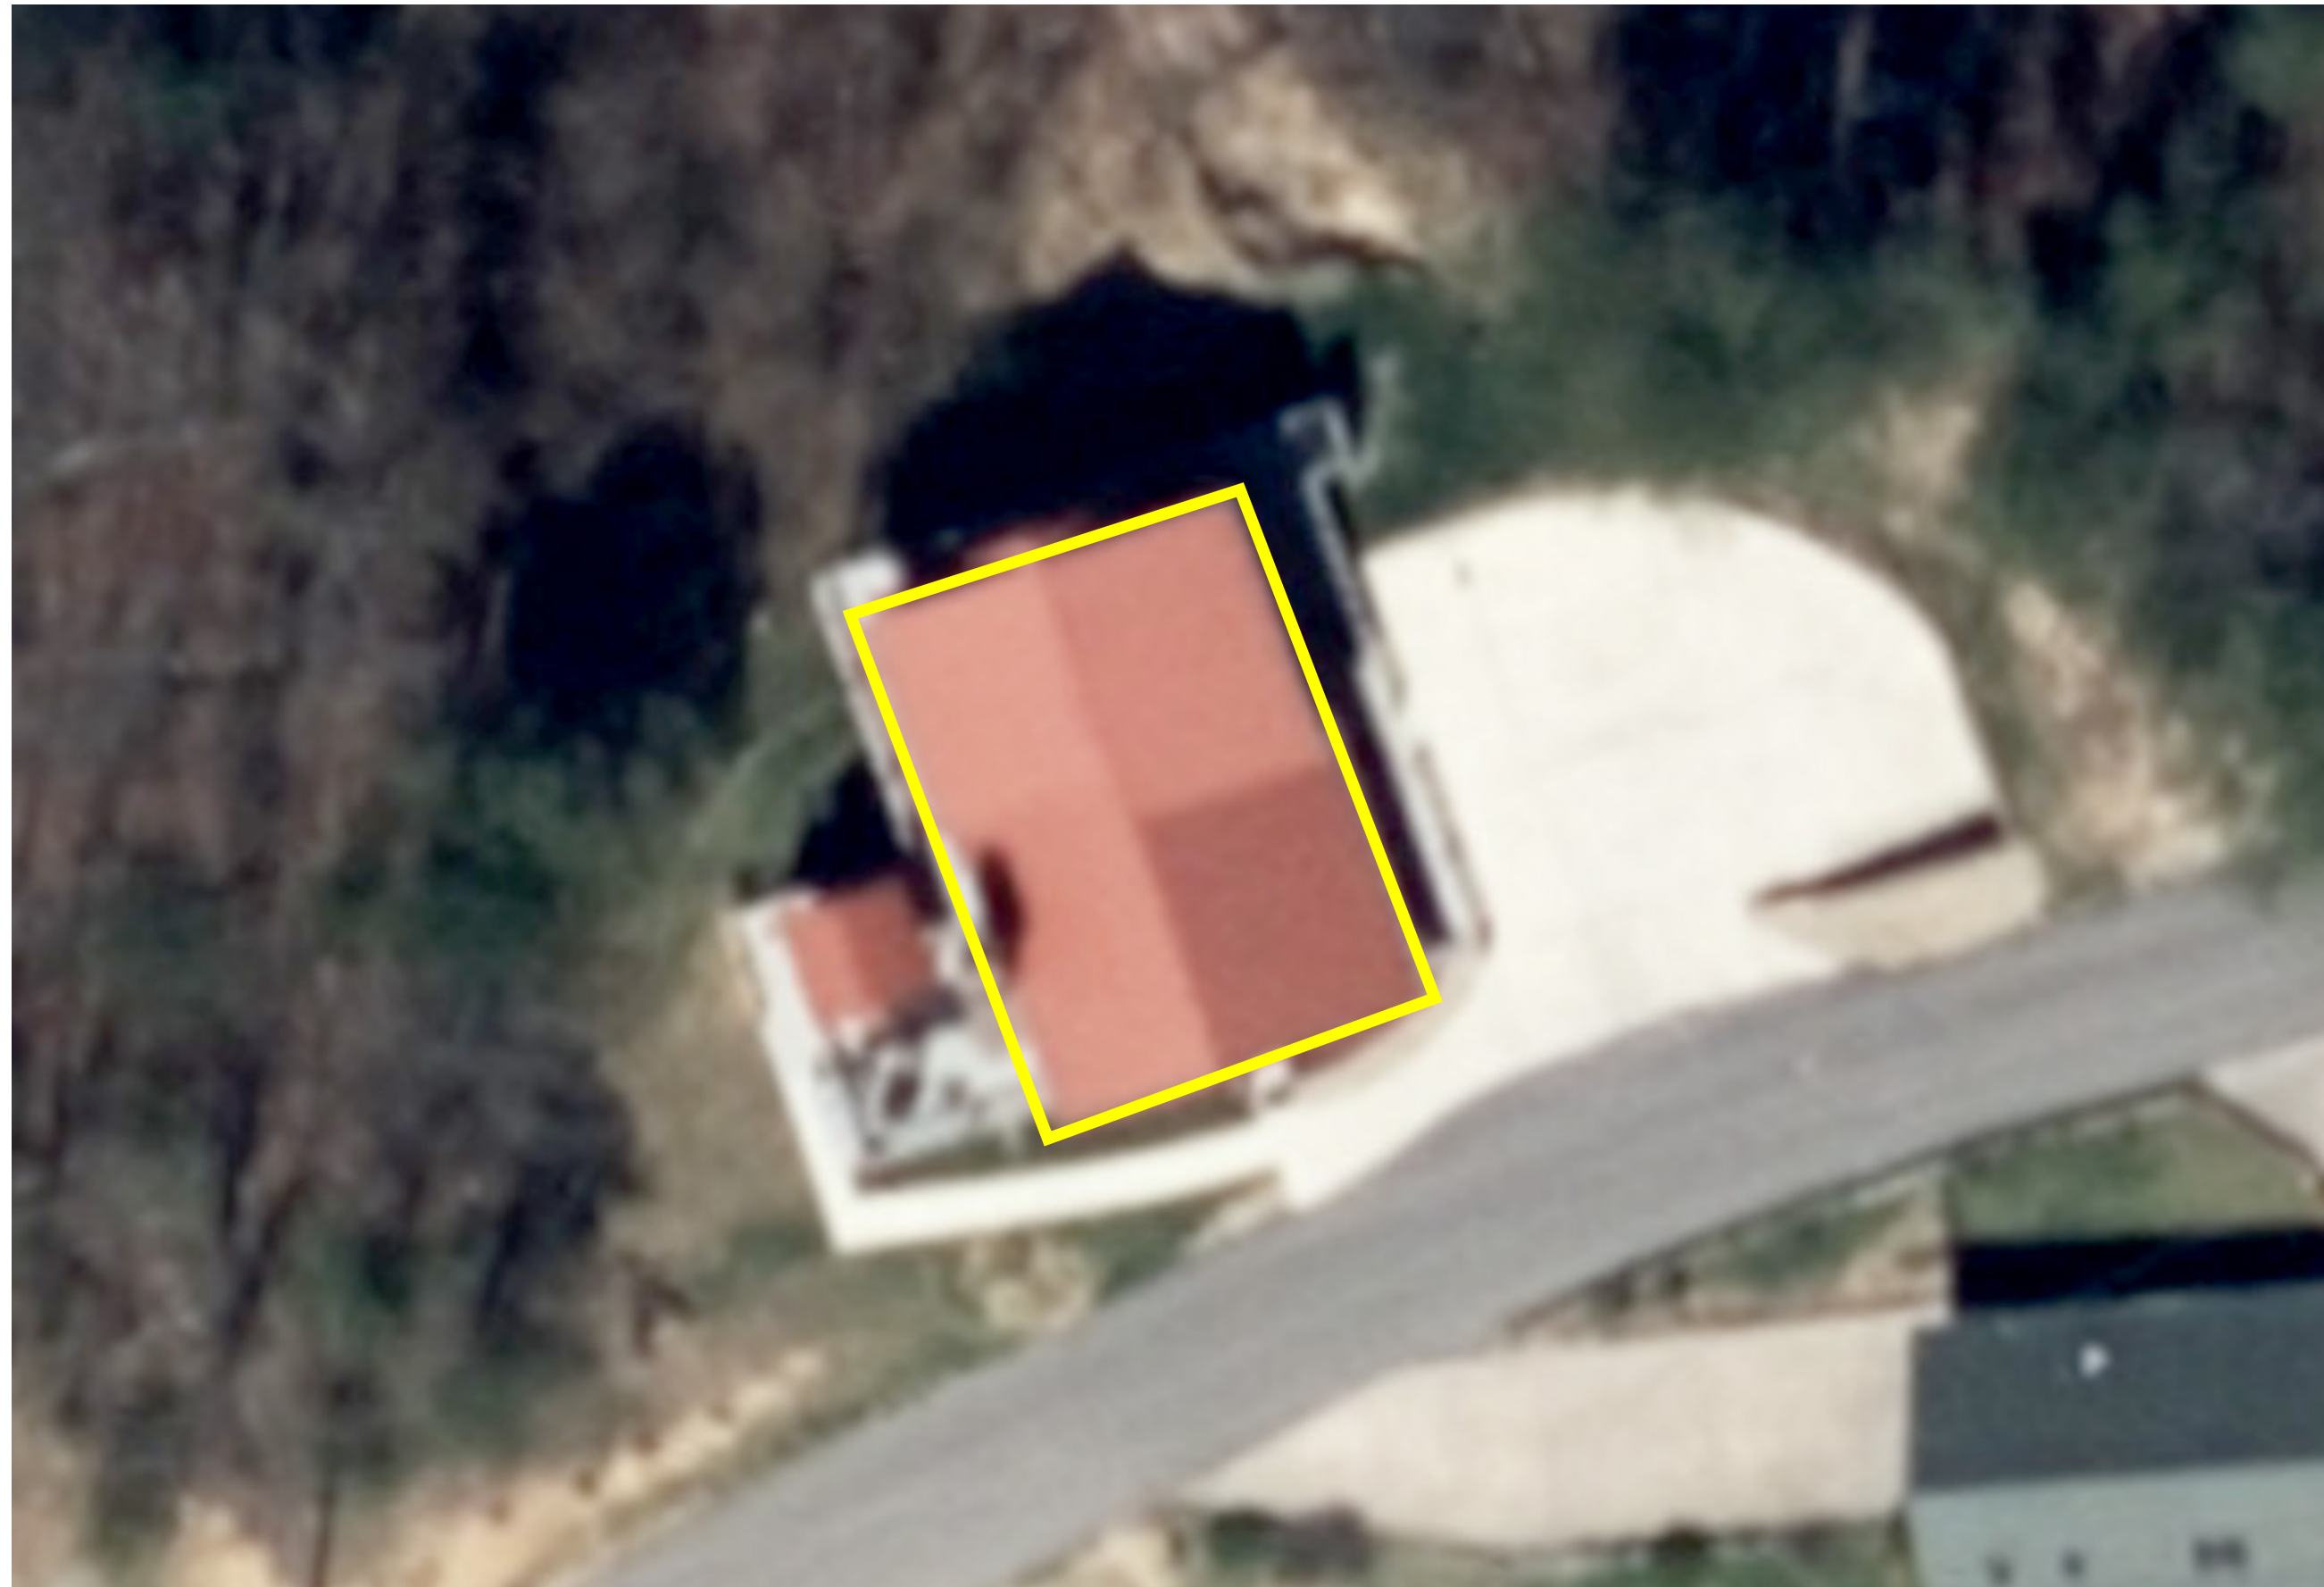
Pre-Damage Report: Primary Building Attributes + Footprint

Analysis based on 03 April 2021 imagery

Attribute	Value	Confidence
Ground elevation	1956.1 ft	
Footprint area	1579.93 ft ²	
Roof material	metal	93%
Missing roof material	0%	N/A
Roof condition	5/5	
Roof discoloration	0%	N/A
Roof tarp	0%	N/A
Roof shape	gable	96%
Roof solar	No	N/A
Roof centroid	35.744056 -83.643274	
Tree cover over roof	0%

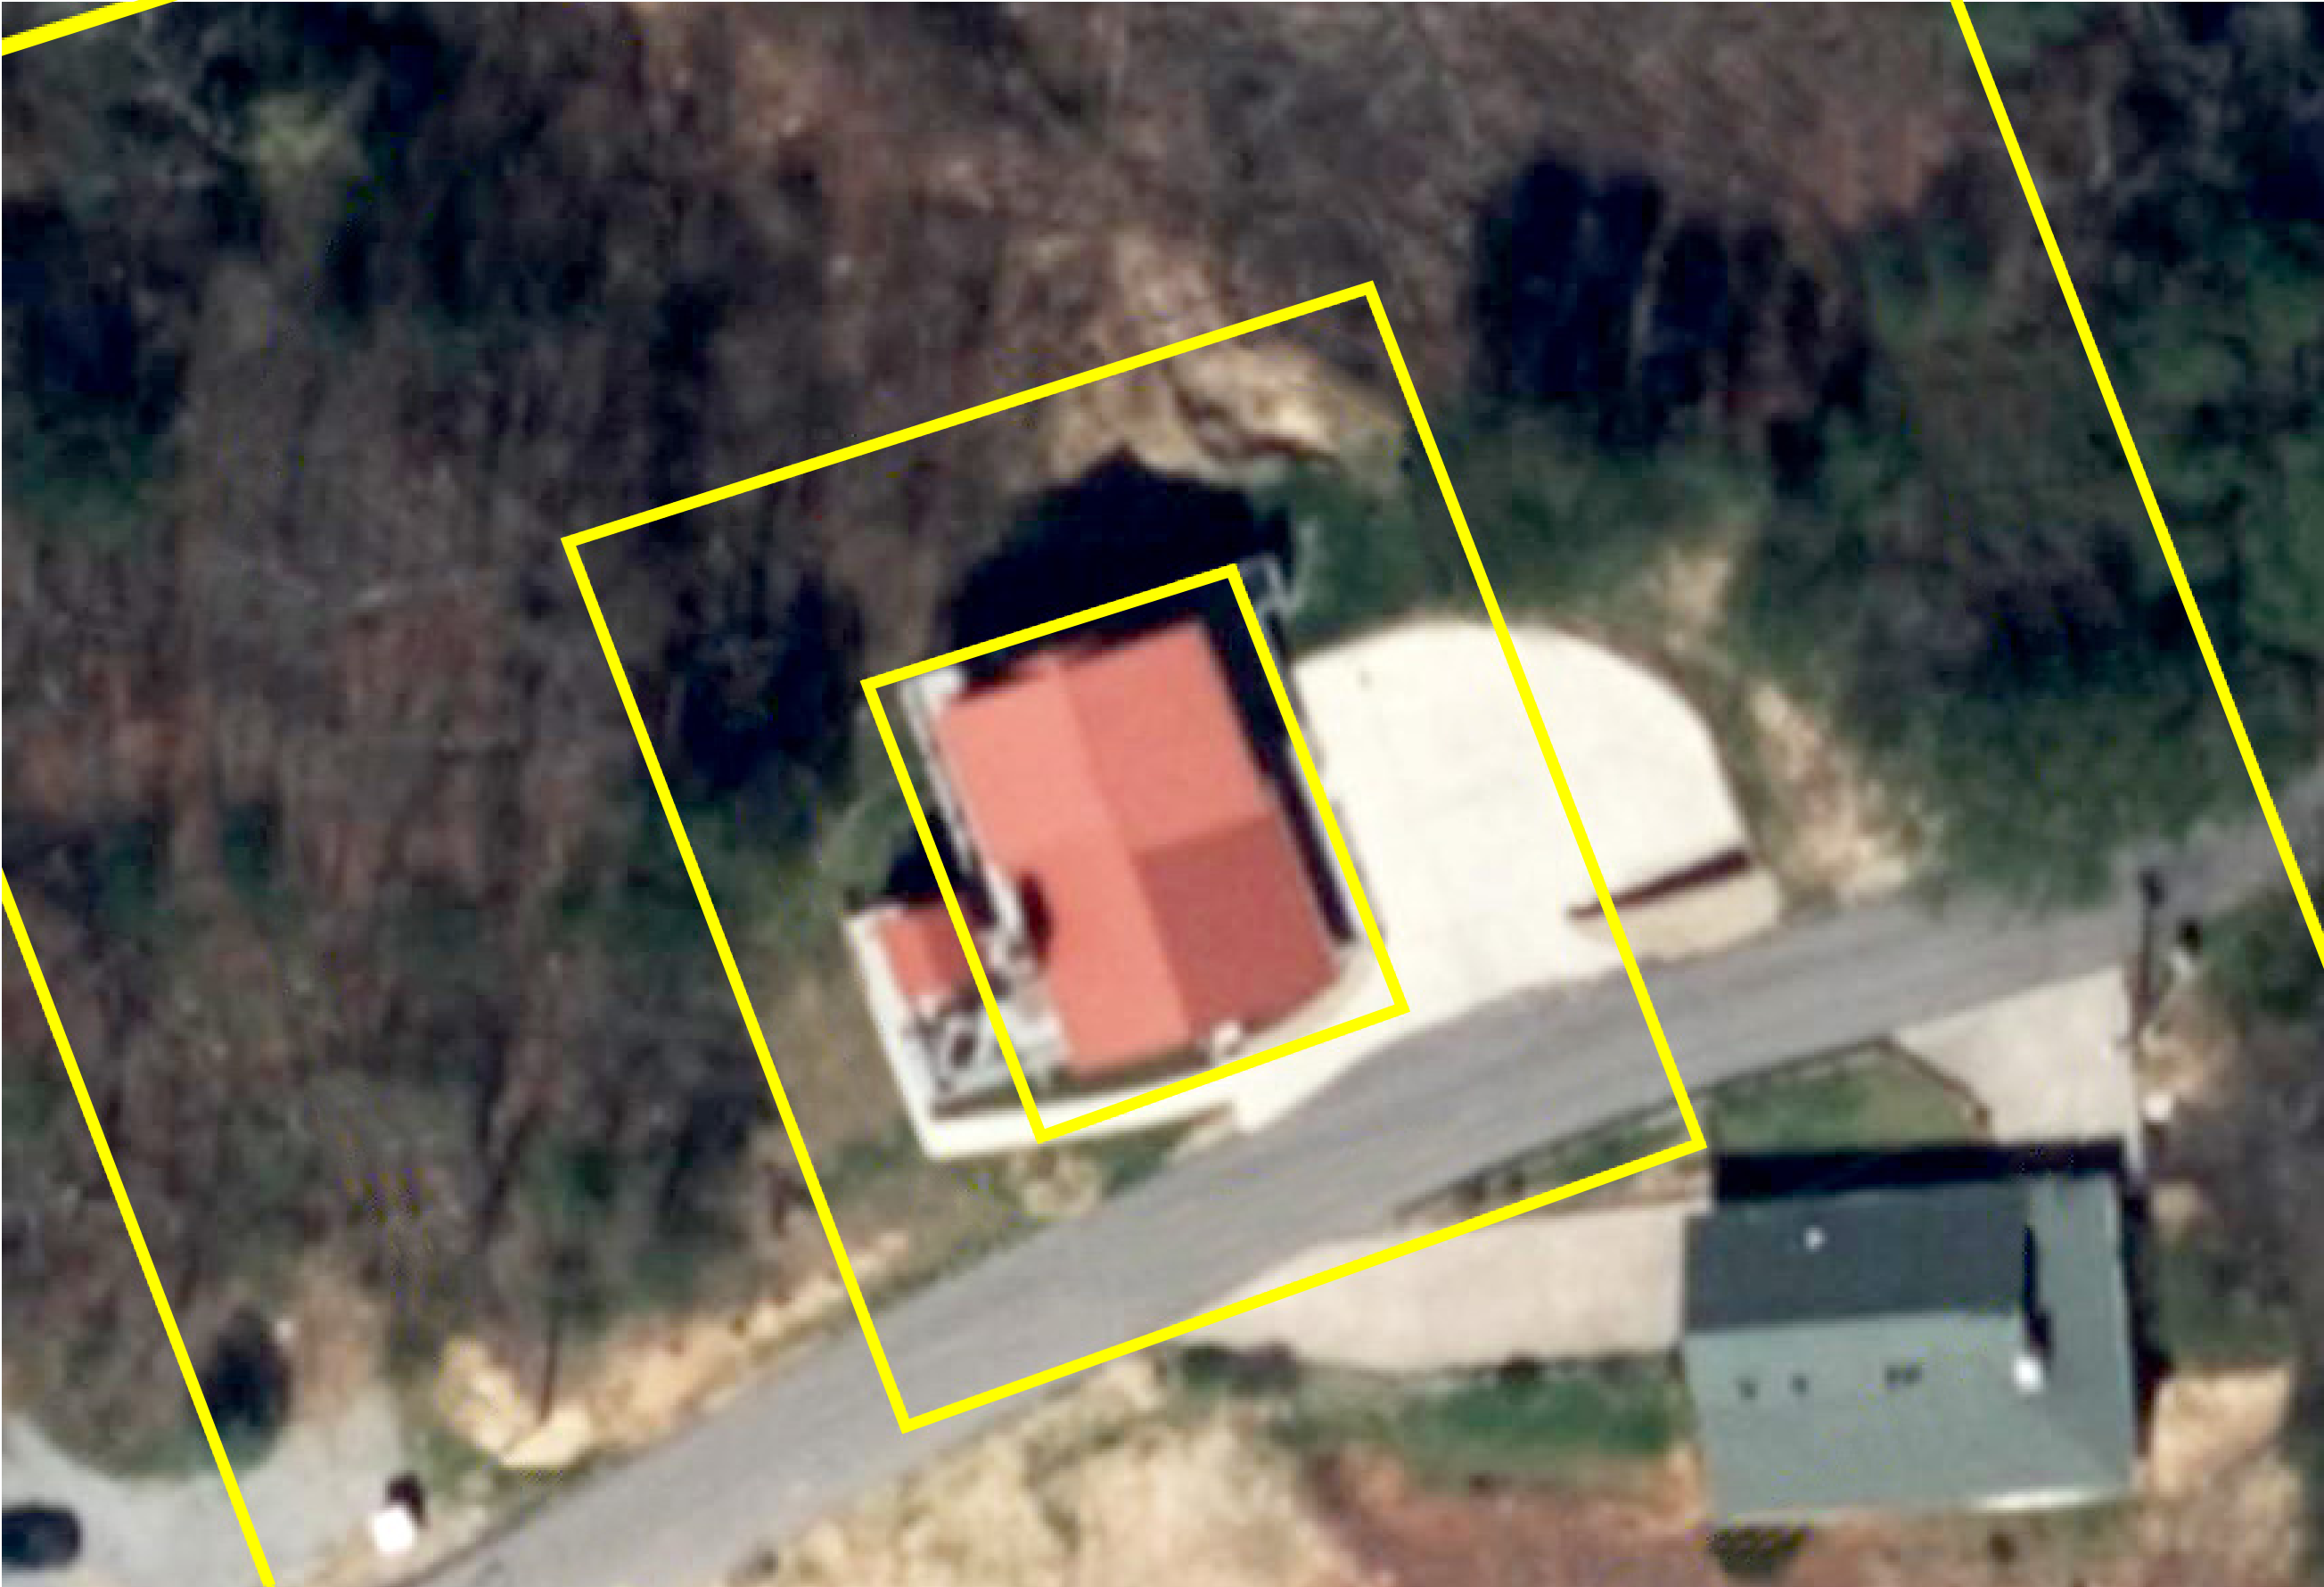
Pre-Damage Report: Defensible Space

Analysis based on 03 April 2021 imagery

Defensible Space	Value
DSB 5 ft	N/A
DSB 30 ft	1%
DSB 100 ft	4%
DSB 200 ft	N/A
DST 5 ft	N/A
DST 30 ft	15%
DST 100 ft	49%
DST 200 ft	N/A

Metrics above relate to 5, 30, 100, and 200 feet buffers for both buildings and trees; ex: 4% of the 100 ft buffer contains other buildings.
