Elements: Damage Report

Gray Sky Damage Assessment

289/291 Tropical Shore Way
Fort Myers Beach FL 33931
United States

Thu, 1 June 2023

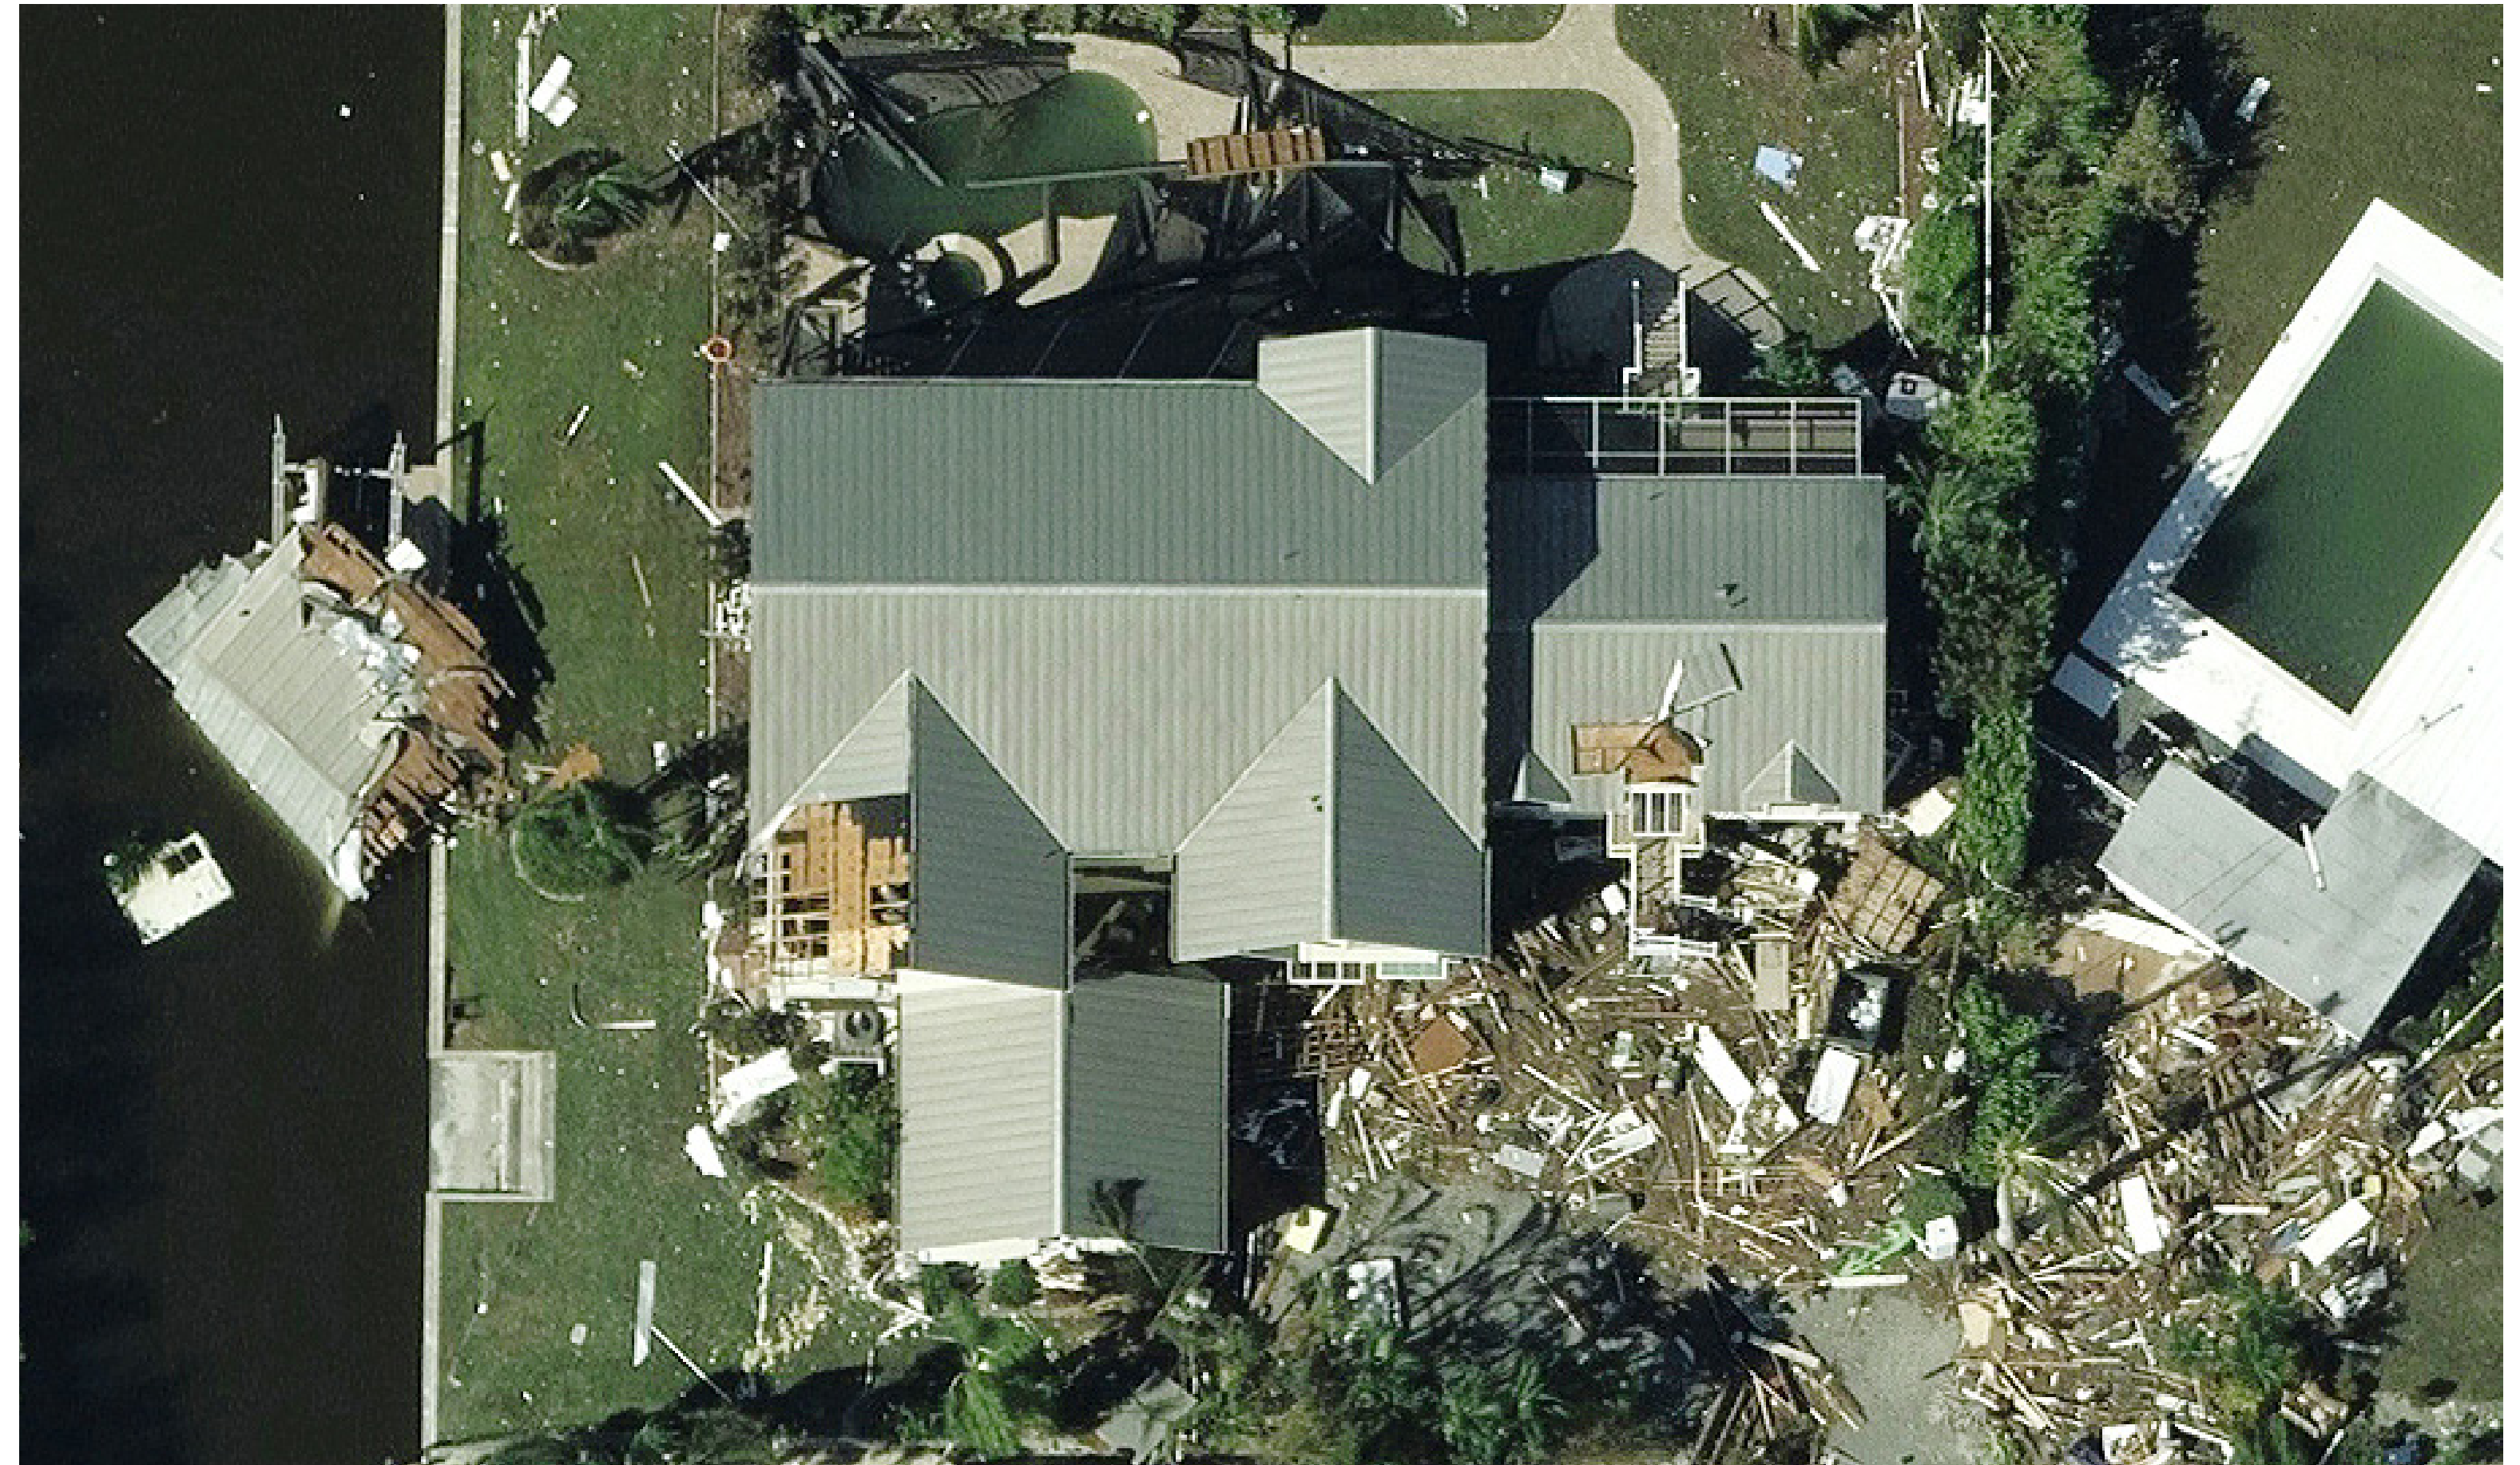
Damage Report: Primary Building Assessment + Footprint

Analysis based on 29 September 2022 imagery

Attribute	Value
Catastrophe score	50/100
Approx. FEMA score	FEMA 3 / Moderate
Roof structure damage	1.4%
Missing material	0.2%
Tarp covering roof	0%
Roof debris	0%
Roof discoloration	0.07%
