# Elements: Damage Report

Gray Sky Damage Assessment

725 Lydia Court  
Harvey LA 70058  
United States

D89122101VE

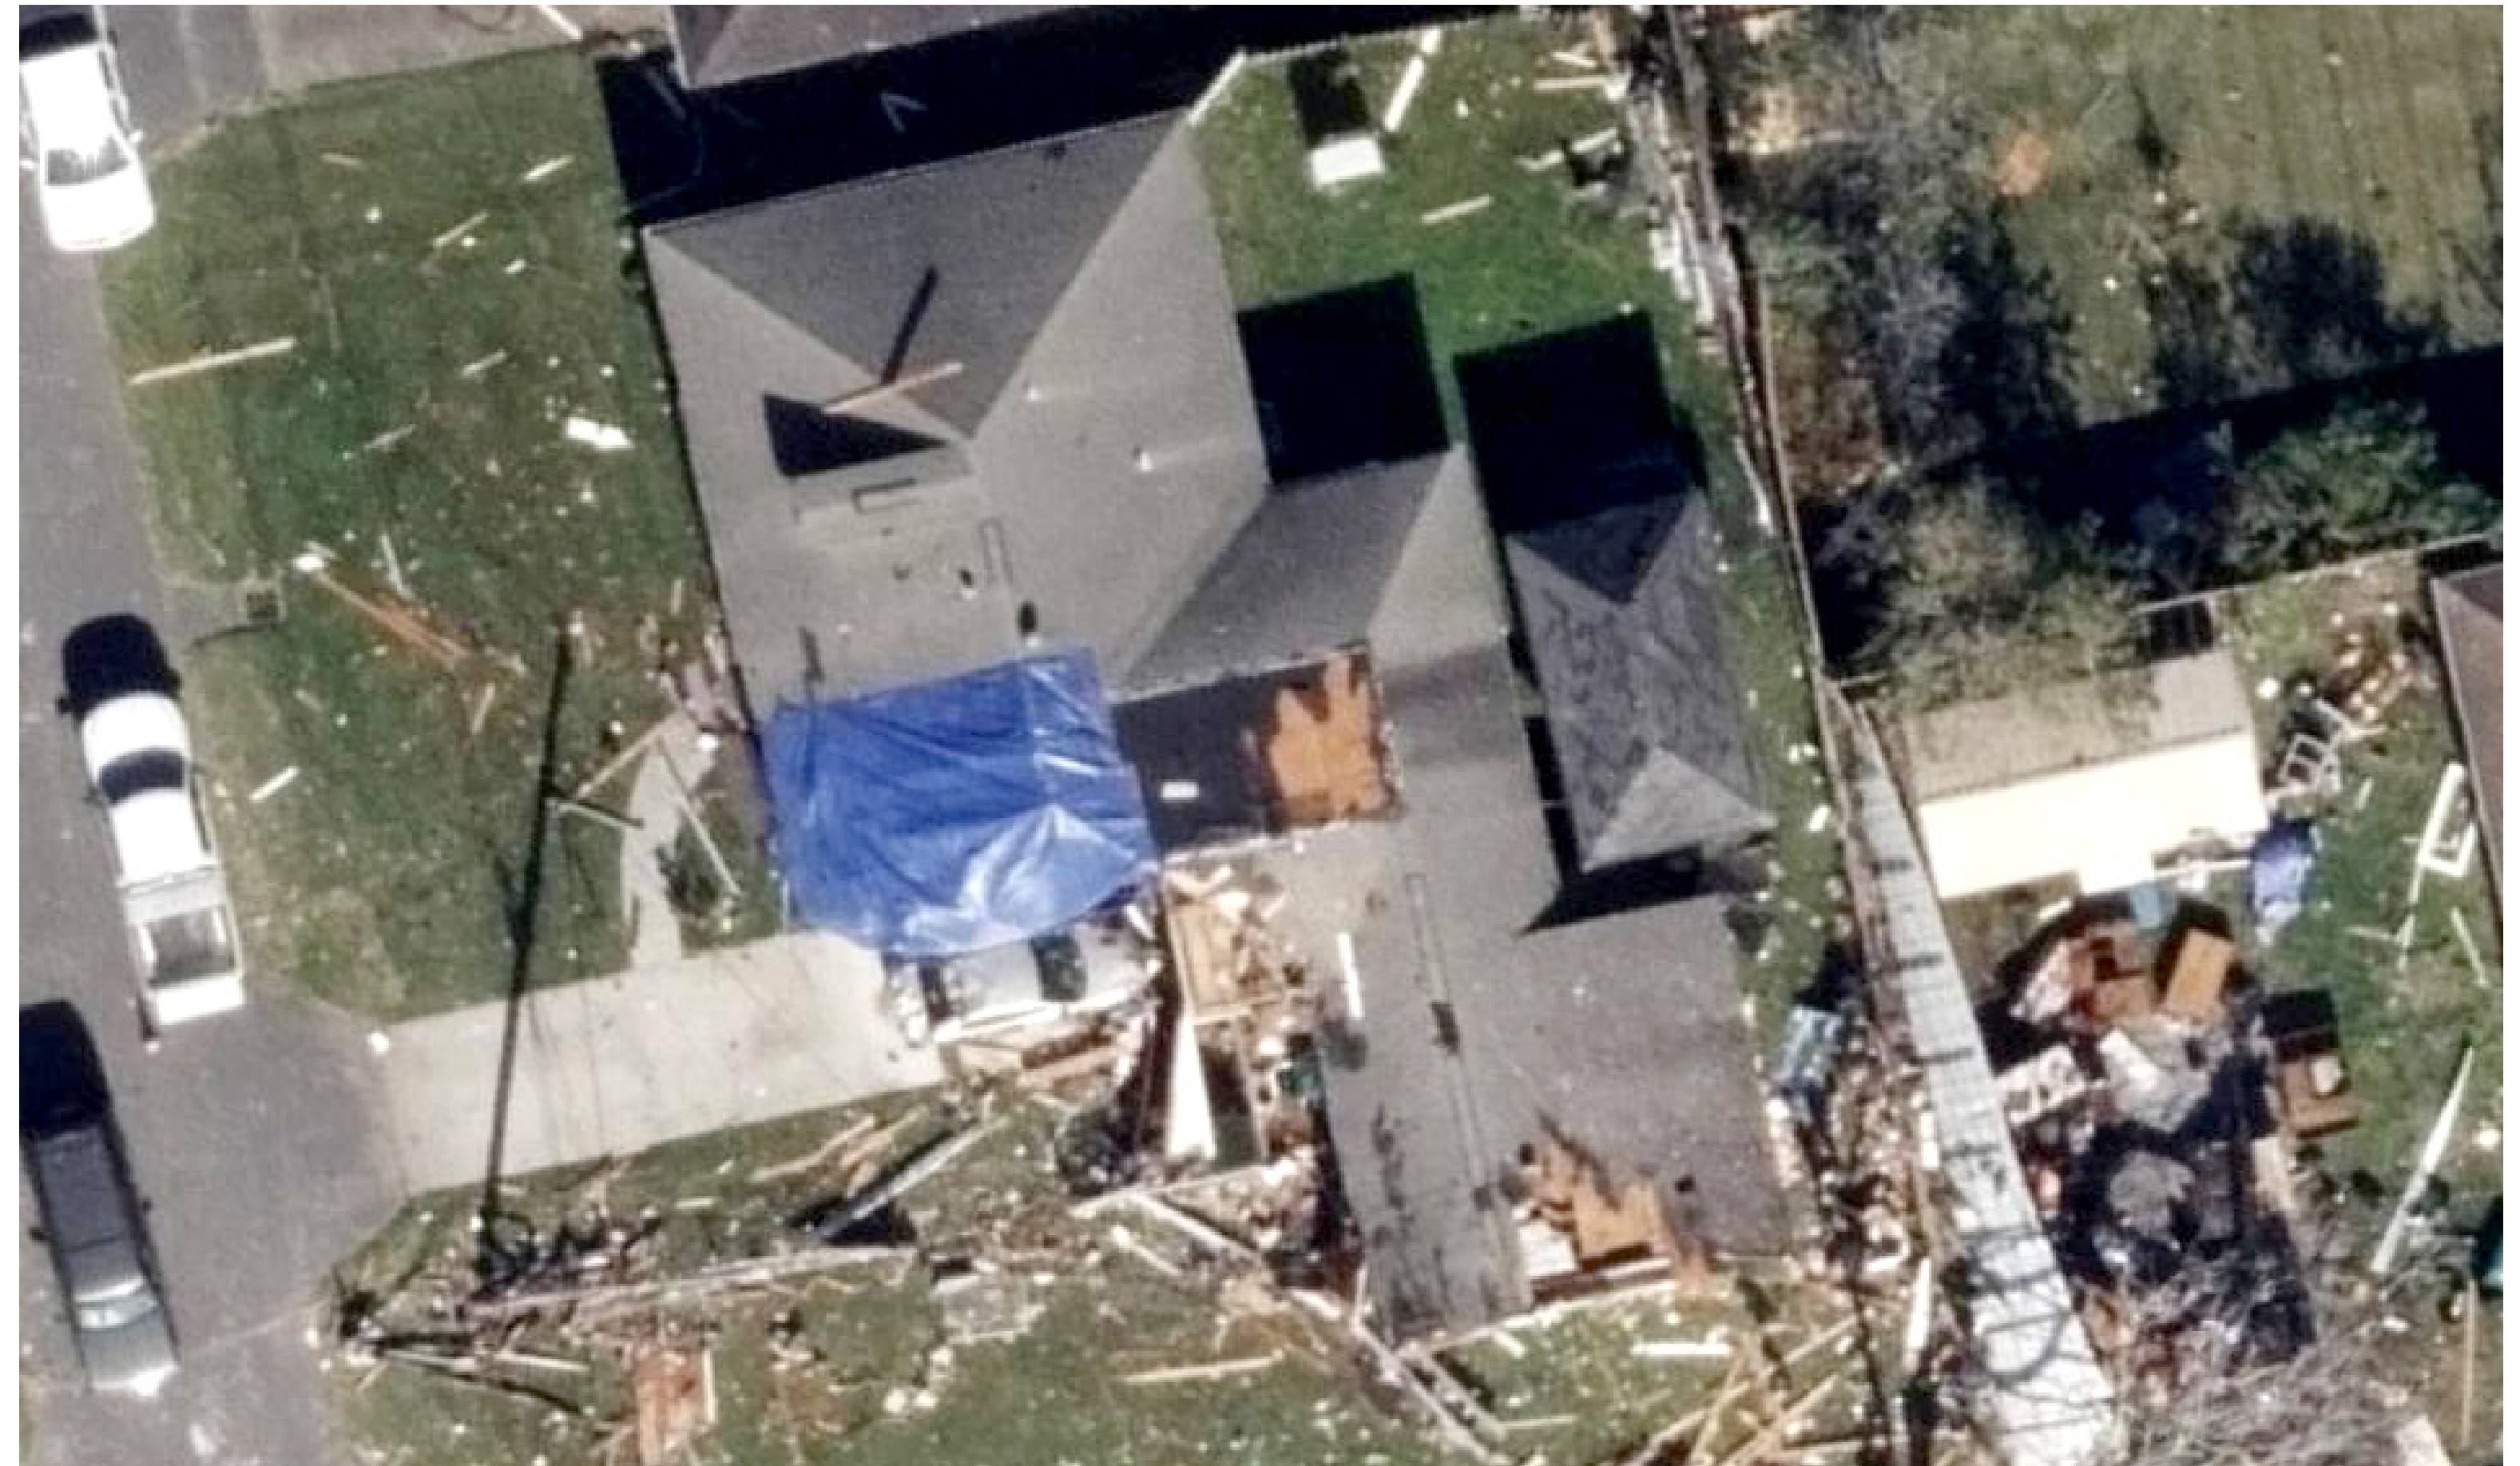
# Damage Report: Primary Building Assessment + Footprint

Analysis based on 15 December 2022 imagery

Attribute	Value
Catastrophe score	64/100
Approx. FEMA score	FEMA 4 / Major
Roof structure damage	5.32%
Missing material	10.56%
Tarp covering roof	12.89%
Roof debris	0%
Roof discoloration	27.9%
